## Pre-Purchase Standard Property & Timber Pest Report

## PRE-PURCHASE STANDARD PROPERTY & TIMBER PEST REPORT

Report number:	AI23-0
Inspection Date:	24th Mar, 2023
Property Address	Queensland, 4509 Australia

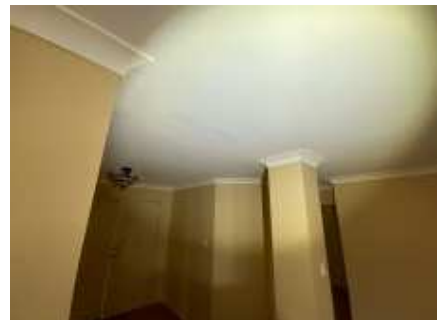
Movement cracks to ceiling and/or cornices. Recommend engaging a plasterer to repairs/replace to prevent further deterioration, Living room

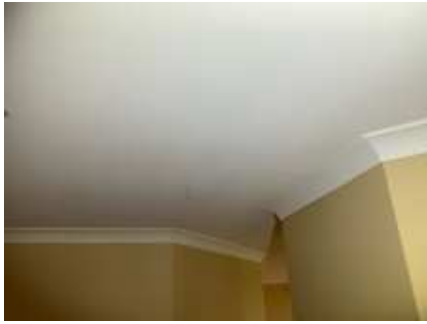
Movement cracks to ceiling and/or cornices. Recommend engaging a plasterer to repairs/replace to prevent further deterioration, Living room

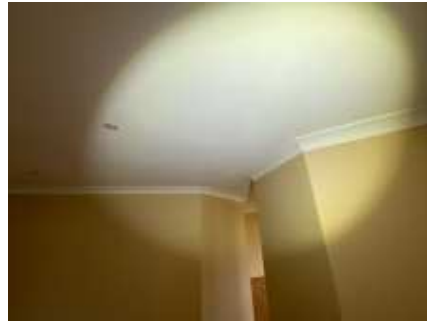
Movement cracks to ceiling and/or cornices. Recommend engaging a plasterer to repairs/replace to prevent further deterioration, Living room

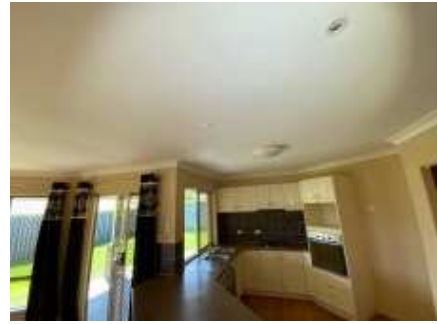
Sagging ceilings. Recommend engaging a plasterer to repair/replace the ceiling to prevent further deterioration,, Dining room

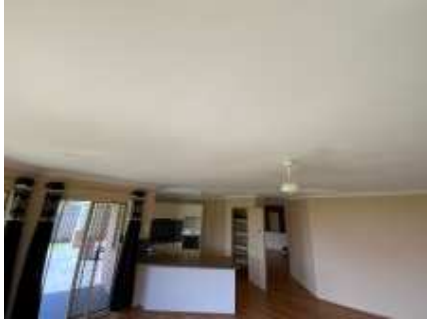
Sagging ceilings. Recommend engaging a plasterer to repair/replace the ceiling to prevent further deterioration,, Dining room

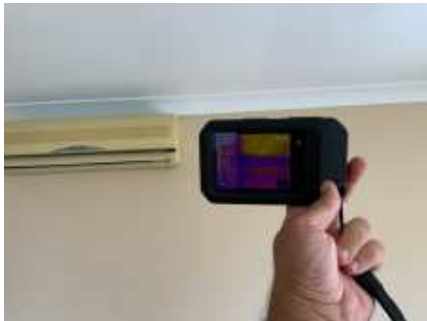
The property shows signs of termite damage. Due to the possibility of concealed structural damage recommend removing any linings that may be concealing structural damage and properly assessing the structural integrity of the building. Recommend engaging a builder to undertake an invasive building inspection and undertake any repairs necessary. Recommend the above be implemented as soon as practical

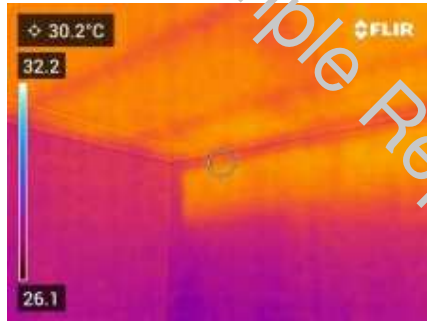
The property shows signs of termite damage. Due to the possibility of concealed structural damage recommend removing any linings that may be concealing structural damage and properly assessing the structural integrity of the building. Recommend engaging a builder to undertake an invasive building inspection and undertake any repairs necessary. Recommend the above be implemented as soon as practical

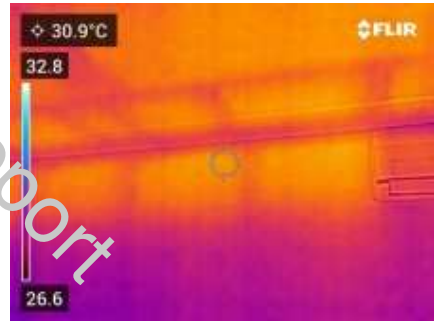
The property shows signs of termite damage. Due to the possibility of concealed structural damage recommend removing any linings that may be concealing structural damage and properly assessing the structural integrity of the building. Recommend engaging a builder to undertake an invasive building inspection and undertake any repairs necessary. Recommend the above be implemented as soon as practical

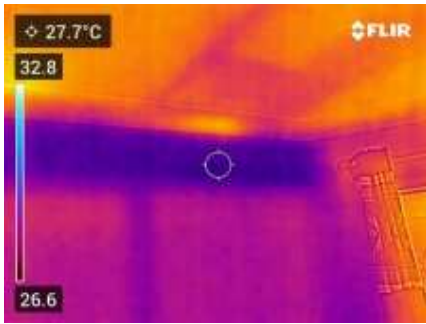
The property shows signs of termite damage. Due to the possibility of concealed structural damage recommend removing any linings that may be concealing structural damage and properly assessing the structural integrity of the building. Recommend engaging a builder to undertake an invasive building inspection and undertake any repairs necessary. Recommend the above be implemented as soon as practical

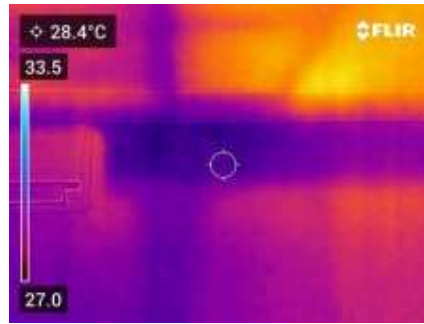
The property shows signs of termite damage. Due to the possibility of concealed structural damage recommend removing any linings that may be concealing structural damage and properly assessing the structural integrity of the building. Recommend engaging a builder to undertake an invasive building inspection and undertake any repairs necessary. Recommend the above be implemented as soon as practical

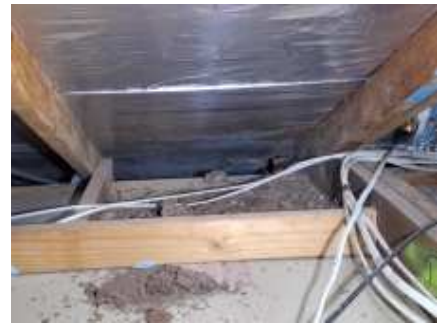
The property shows signs of termite damage. Due to the possibility of concealed structural damage recommend removing any linings that may be concealing structural damage and properly assessing the structural integrity of the building. Recommend engaging a builder to undertake an invasive building inspection and undertake any repairs necessary. Recommend the above be implemented as soon as practical

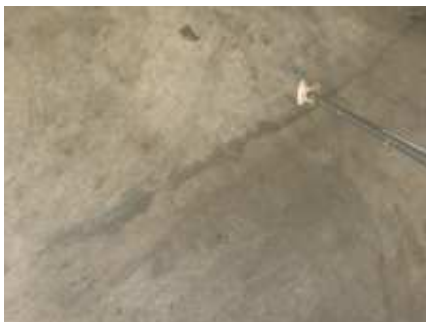
Cracking was observed on parts of the floors. Recommend a structural engineer be engaged to inspect and provide appropriate advice and recommendations to reduce the risk of further deterioration to the building., Garage floor

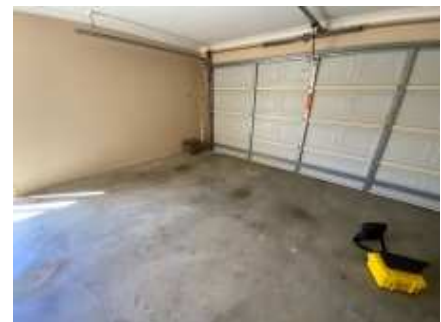
Cracking was observed on parts of the floors. Recommend a structural engineer be engaged to inspect and provide appropriate advice and recommendations to reduce the risk of further deterioration to the building., Garage floor

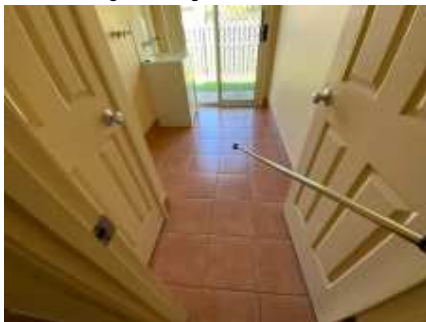
A few cracked and damaged tiles to the floor, recommend engaging a tiler to replace the damaged tiles and avoid further deterioration, Most of the floor tiles are drummy.

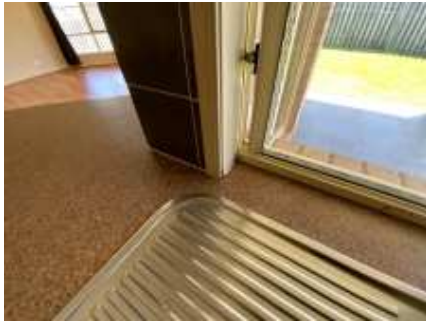
Wood rot/water damage to the kitchen window timber frame, a carpenter recommended to repair/replace and avoid further deterioration

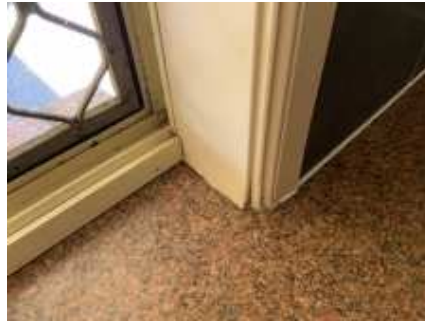
Wood rot/water damage to the kitchen window timber frame, a carpenter recommended to repair/replace and avoid further deterioration

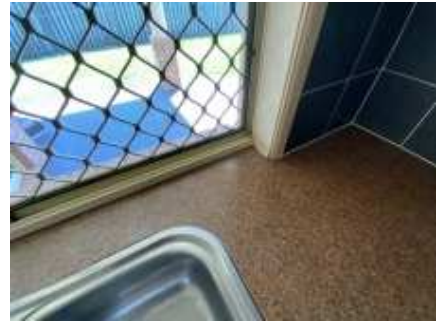
Wood rot/water damage to the kitchen window timber frame, a carpenter recommended to repair/replace and avoid further deterioration

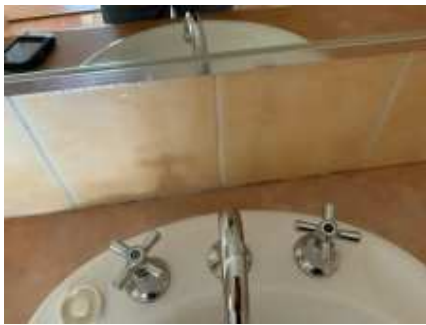
Cracked/loose/missing sealant/grout to parts of bathroom. Recommend resealing to reduce the risk of water leaks and damage

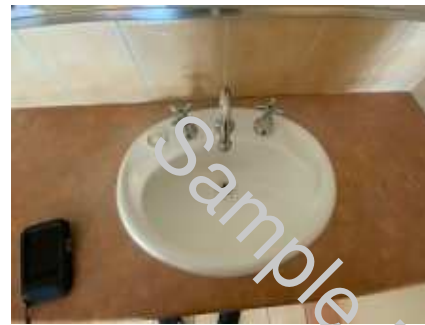
Cracked/loose/missing sealant/grout to parts of bathroom. Recommend resealing to reduce the risk of water leaks and damage

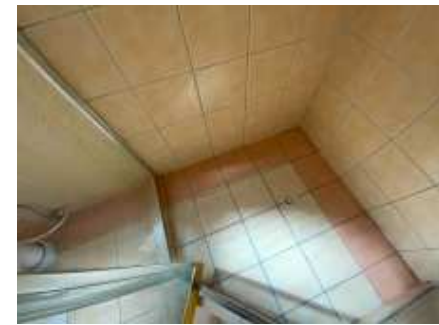
Cracked/loose/missing sealant/grout to parts of bathroom. Recommend resealing to reduce the risk of water leaks and damage

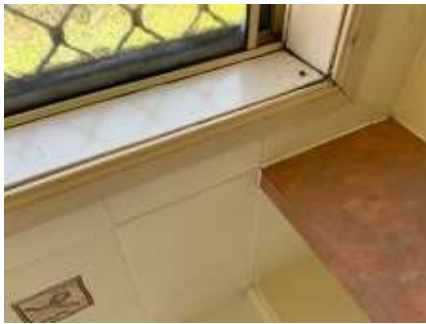
A few cracked tiles to the bathroom. Recommend engaging a tiler to repair/replacing to reduce the risk of water leaks and damage, Movement crack to the wall which affected the tile's mortars

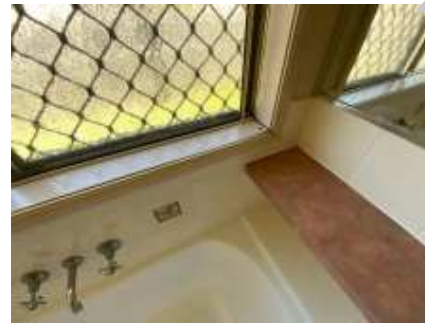
A few cracked tiles to the bathroom. Recommend engaging a tiler to repair/replacing to reduce the risk of water leaks and damage, Movement crack to the wall which affected the tile's mortars

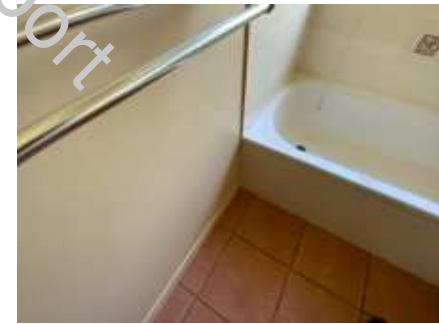
Cracked/loose/missing sealant/grout to parts of bathroom. Recommend resealing to reduce the risk of water leaks and damage

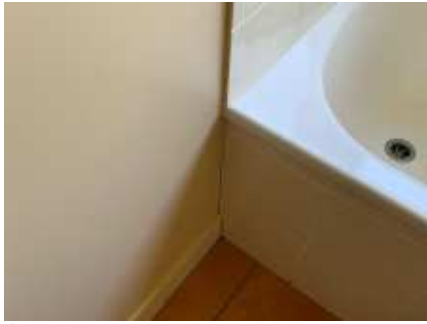
Cracked/loose/missing sealant/grout to parts of bathroom. Recommend resealing to reduce the risk of water leaks and damage

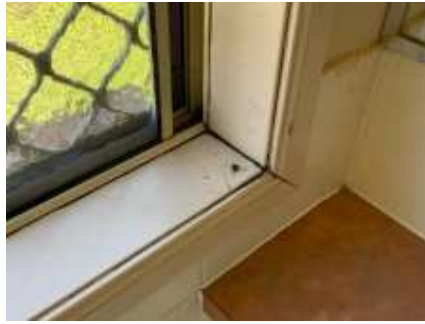
Moisture damage to the windows frame, recommend engaging a carpenter to repair/replace the affected area and avoid further deterioration

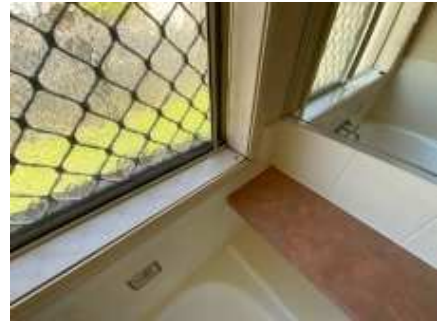
Moisture damage to the windows frame, recommend engaging a carpenter to repair/replace the affected area and avoid further deterioration

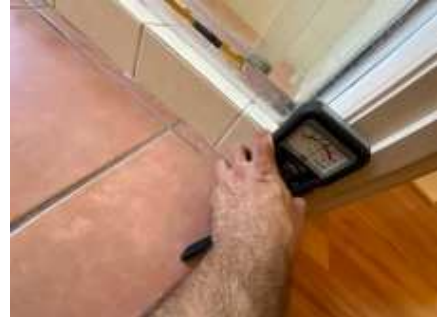
High moisture readings to the walls around the shower. Recommend engaging a builder/plumber for further inspection to determine if the shower needs re-building/waterproofing or it can be repaired easily, Behind the main bathroom shower wall, to the floor and door frame

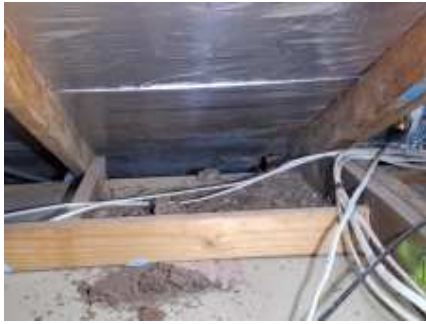
Termite damage to parts of the roof framing. Recommend engaging a builder for further invasive inspection to the area to determine if there is any concealed damage and replace all damaged timbers.

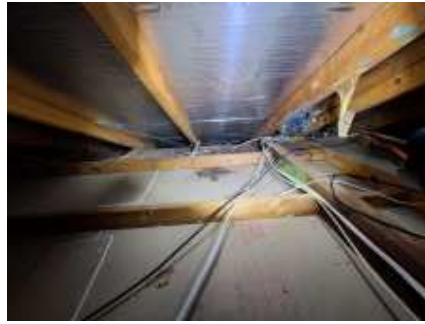
Termite damage to parts of the roof framing. Recommend engaging a builder for further invasive inspection to the area to determine if there is any concealed damage and replace all damaged timbers.

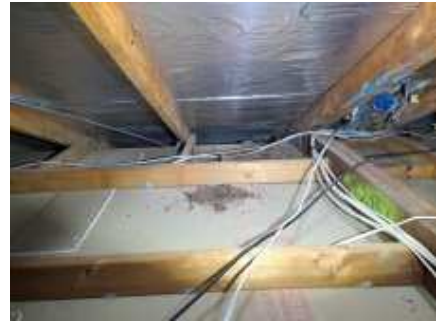
Termite damage to parts of the roof framing. Recommend engaging a builder for further invasive inspection to the area to determine if there is any concealed damage and replace all damaged timbers.

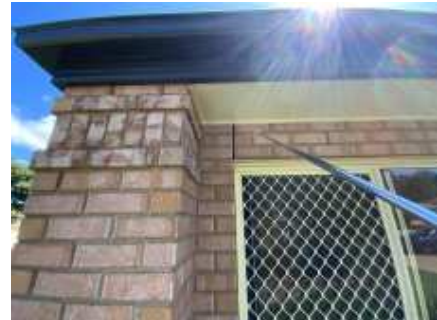
Some parts of the external wall have gaps present. Recommend sealing all the gaps to reduce the risk of water leaks and penetration into the building, Top of the front windows

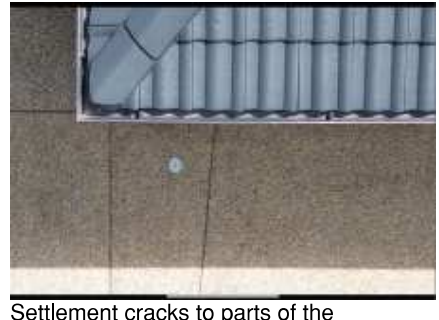
Settlement cracks to parts of the pathway/driveway. Recommend engaging a concreting contractor to repair/replace and avoid further deterioration

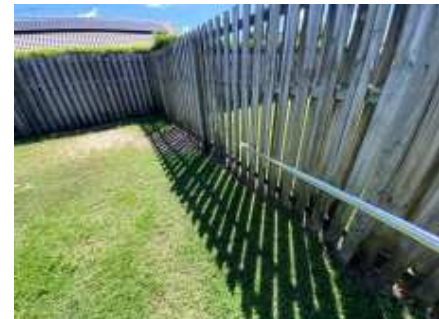
Wood rot to parts of the fences. Recommend engaging a fencing contractor to repair/replace the damaged parts and avoid further deterioration. Make sure all the exposed timbers are painted to maximise the life of the timbers

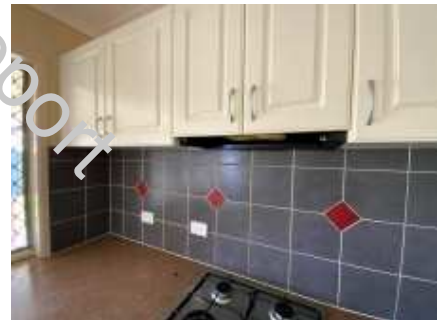
The rangehood is broken, an electrician recommended.

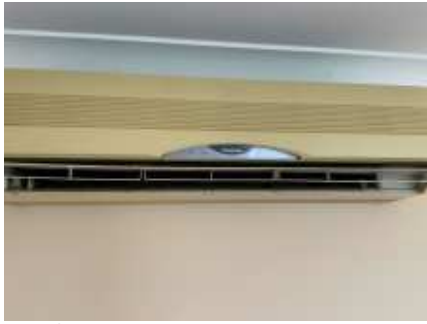
All AC units were working at the time of the inspection, but for a proper testing and gas measurement, a AC technician needs to be engaged

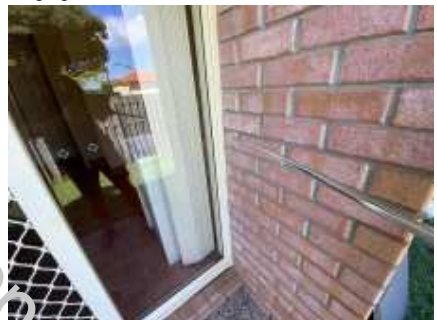
Showing example of the minor gap around door/windows frame, recommend applying silicone to avoid water entry to the wall

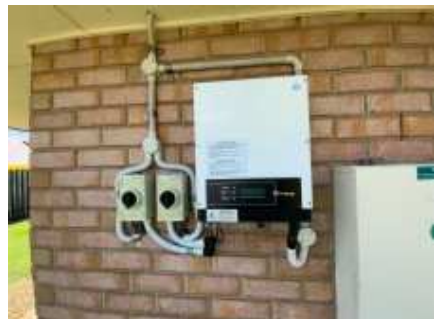
Showing solar panel is working at the time of the inspection, but an electrician recommended to inspect the energy efficiency of the solar units

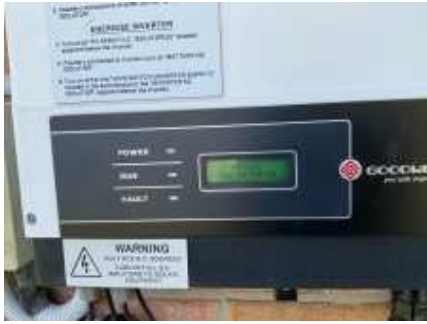
Showing solar panel is working at the time of the inspection, but an electrician recommended to inspect the energy efficiency of the solar units

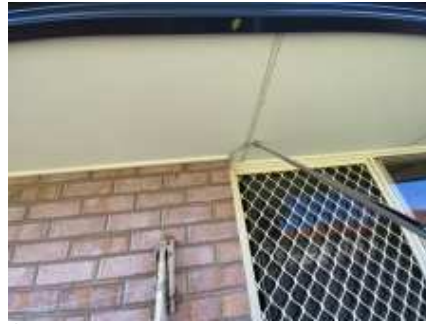
Showing example of the damaged soffit sheet

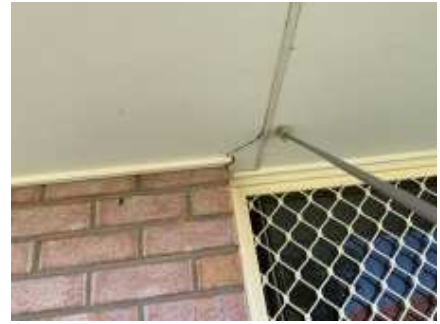
Showing example of the damaged soffit sheet

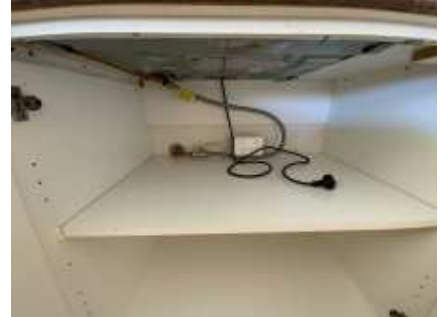
The power point under cook top is not working, an electrician recommended

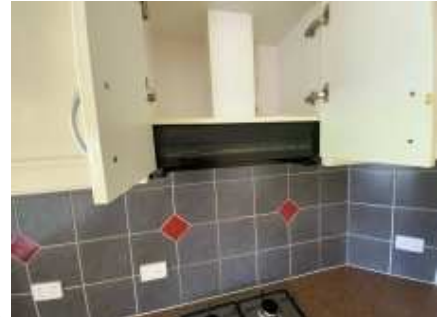
Showing the broken range hood, an electrician recommended to repair/replace and make it usable

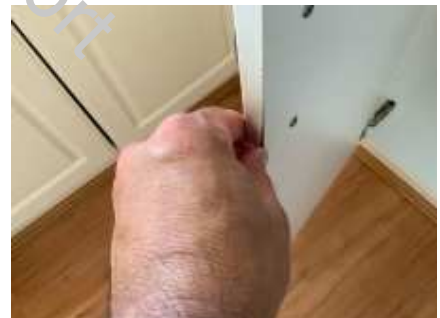
Showing example of loose/missing laminate to the cabinets

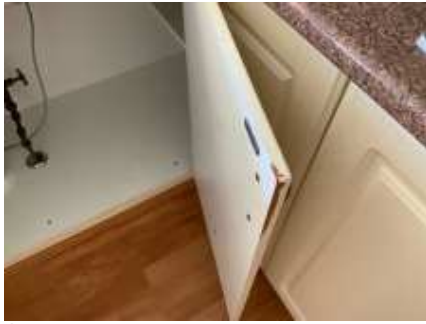
Showing example of loose/missing laminate to the cabinets

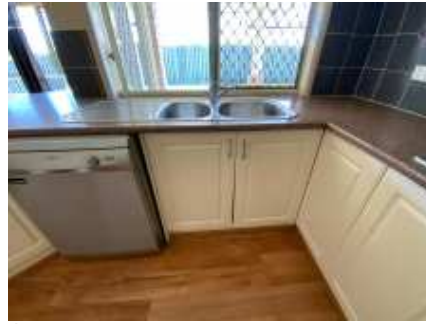
Showing cabinet door needs adjustment

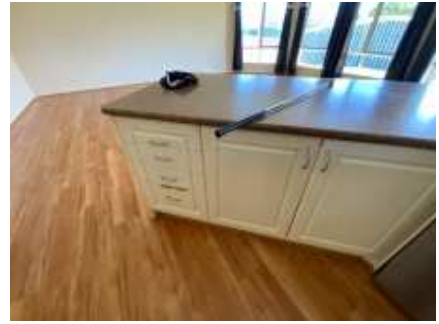
Showing example of loose/missing laminate to the cabinets

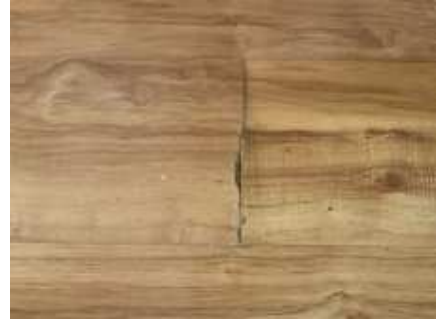
Showing example of the damaged floor board

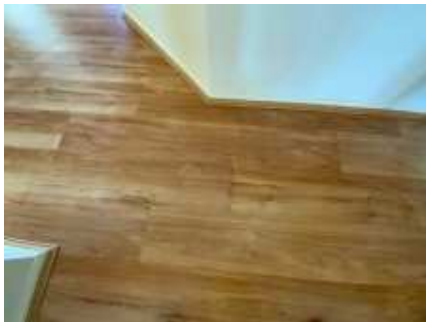
Showing example of the damaged floor board

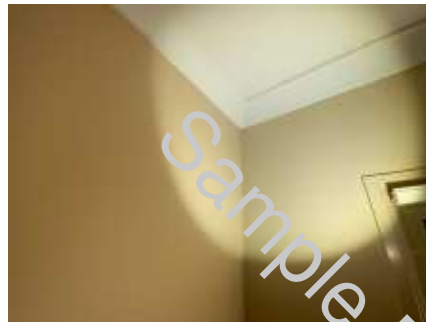
Showing example of settlement cracks, Wall/cornices

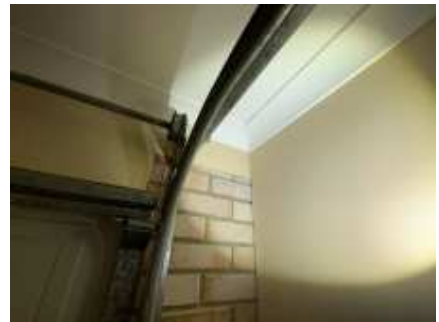
Showing example of settlement cracks, Wall/cornices

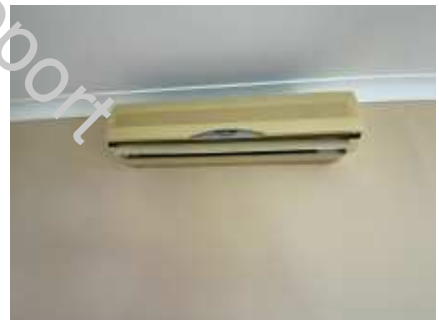
Air conditioning panel remained open, after turning off, an electrician recommended

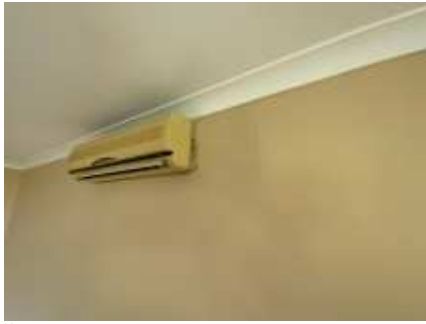
Showing example of the previous attempt to repair the wall

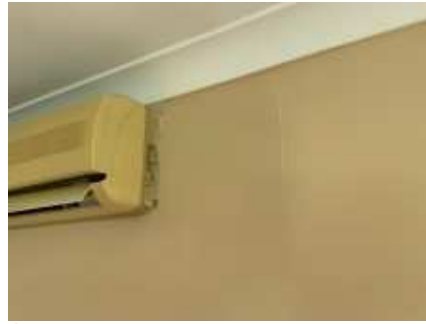
Showing example of the previous attempt to repair the wall

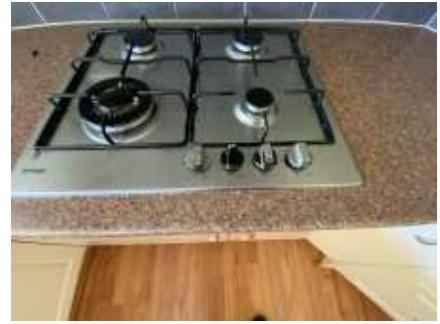
Any services requiring gas will be inoperable when the gas bottles are empty. Recommend further investigations once gas bottles are connected to ensure correctly installed and all services operating correctly. Recommend the above be implemented as soon as practicable. It looks no electricity is connected to the cabinet powerpoint, under cook top.

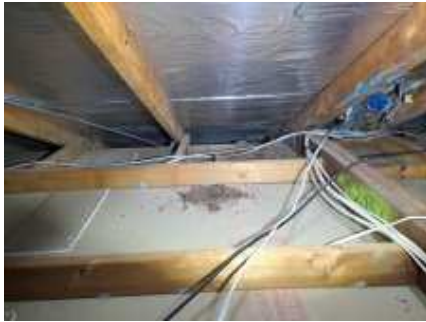
Showing sign of the termite working inside the roof space

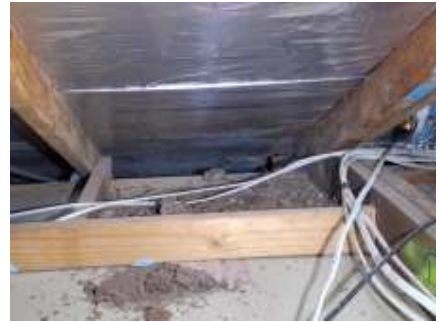
Showing sign of the termite working inside the roof space

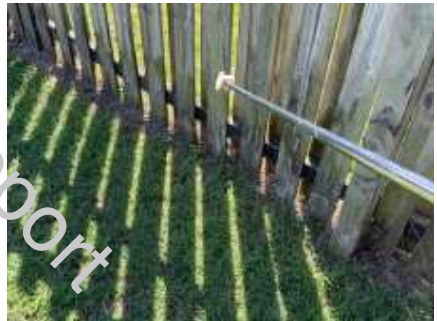
Showing example of the wood rot to the timber

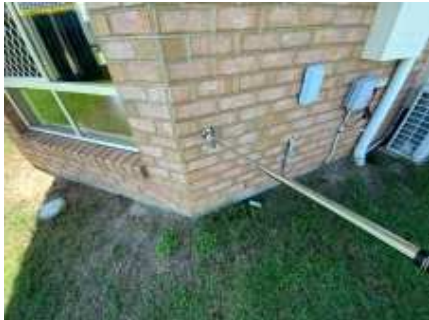
Showing possible source of excessive moisture

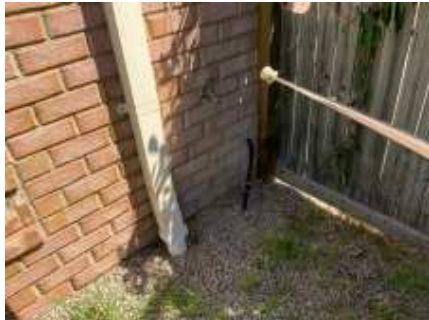
Showing possible source of excessive moisture

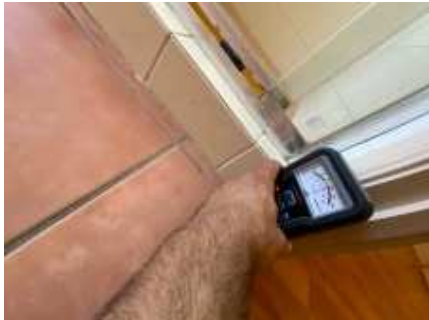
Showing possible source of excessive moisture

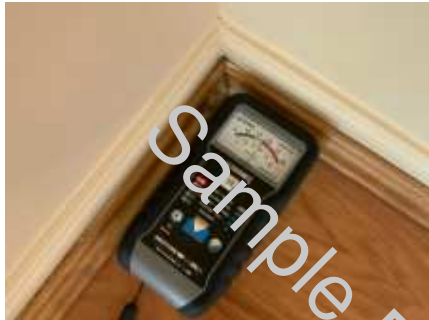
Showing possible source of excessive moisture

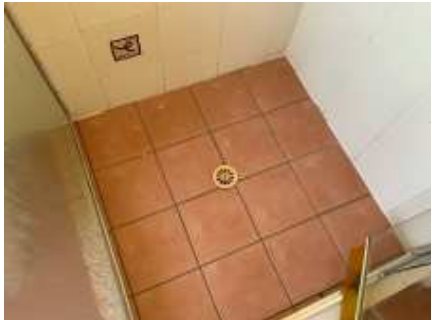
Showing possible source of excessive moisture

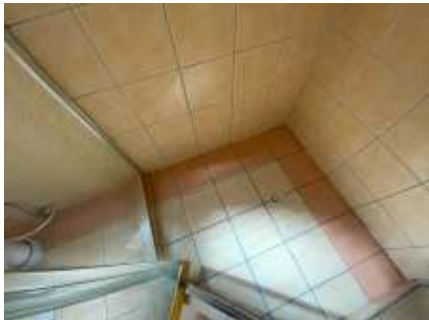
Showing possible source of excessive moisture

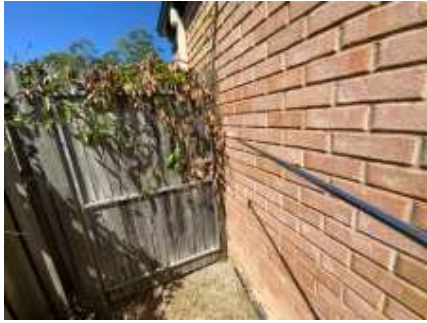
Showing example of the bridging/breaching

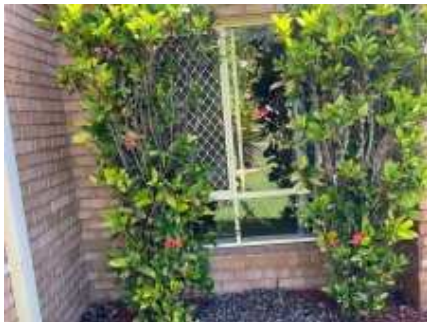
Showing example of the other conducive conditions

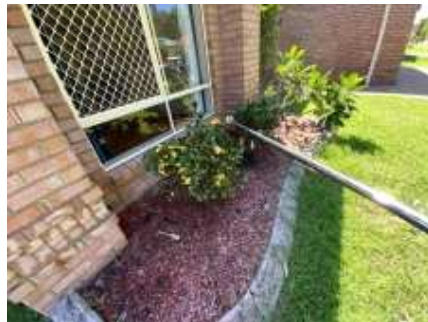
Showing example of the other conducive conditions
