Sample Report

Pre-Purchase Standard
Property & Timber Pest Report

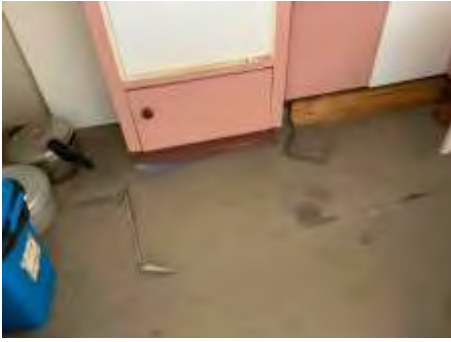
Showing examples of obstructions (e.g. wall, floor, ceiling coverings, cabinets, window furnishings, vegetation, insulation and ducted AC, furniture and stored goods, etc.)

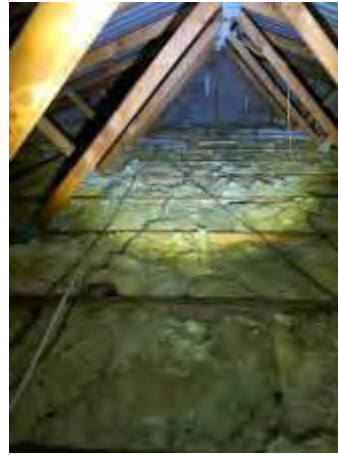
Parts of roof space due to the obstruction

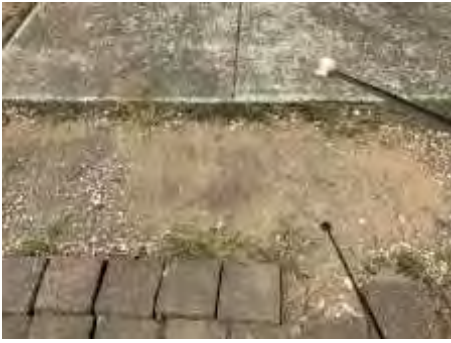
Showing example of uneven pathway

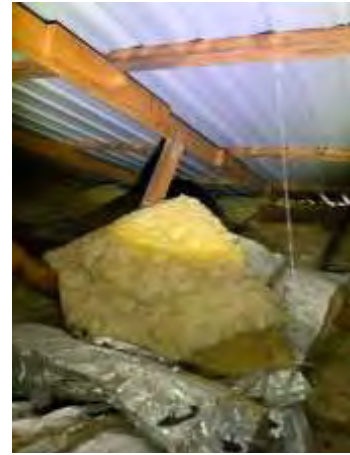
Showing example of metal backed insulation to the roof space

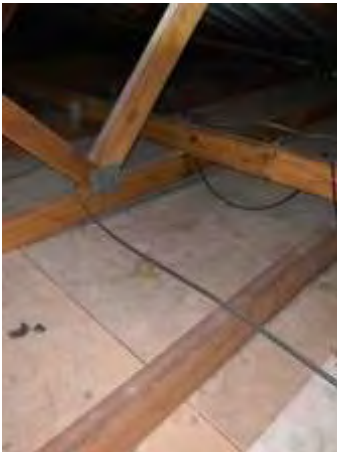
Sagging ceilings. Recommend engaging a plasterer to repair/replace the ceiling to prevent further deterioration,

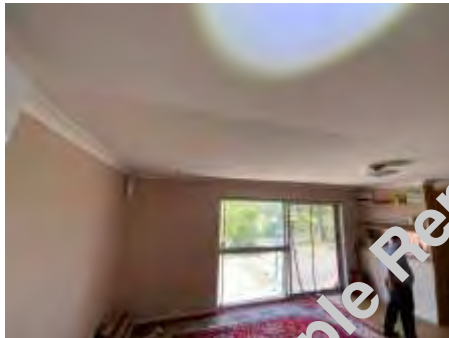
Sagging ceilings. Recommend engaging a plasterer to repair/replace the ceiling to prevent further deterioration,

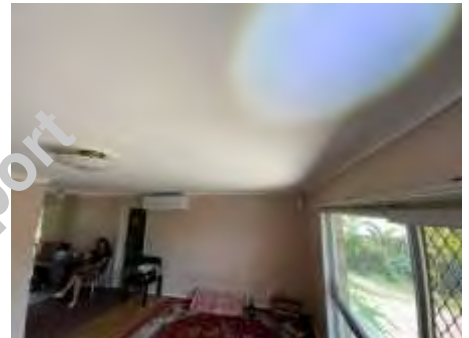
Sagging ceilings. Recommend engaging a plasterer to repair/replace the ceiling to prevent further deterioration,

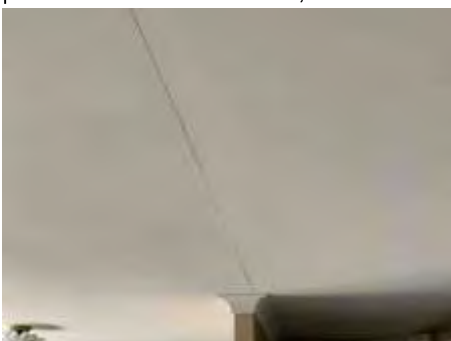
Movement cracks to ceiling and/or cornices. Recommend engaging a plasterer to repairs/replace to prevent further deterioration

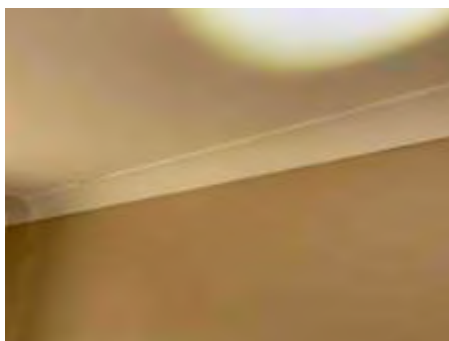
Movement cracks to ceiling and/or cornices. Recommend engaging a plasterer to repairs/replace to prevent further deterioration

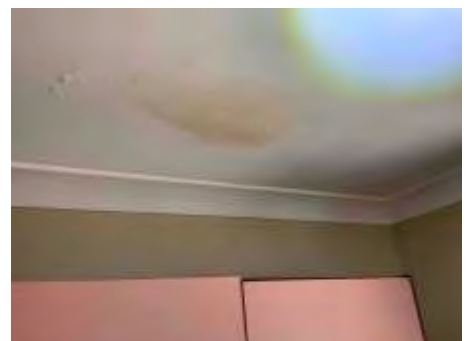
Poor ventilation in Kitchen area. Mould to the ceiling. Needs ventilation improvement

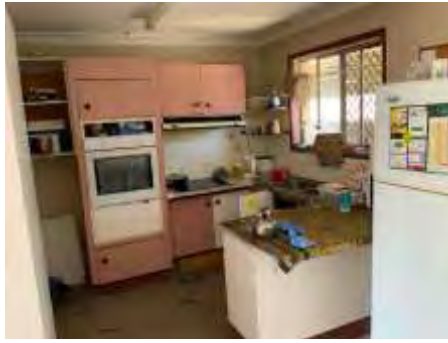
Poor ventilation in Kitchen area. Mould to the ceiling. Needs ventilation improvement

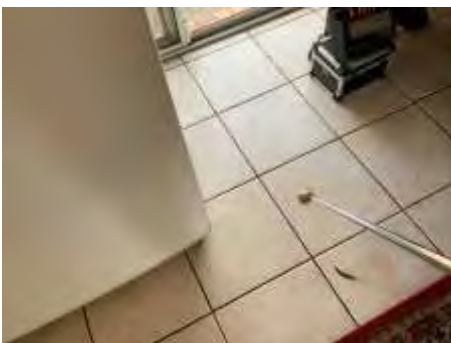
A few drummy tiles to the floor, recommend engaging a tiler to rectify the issue.

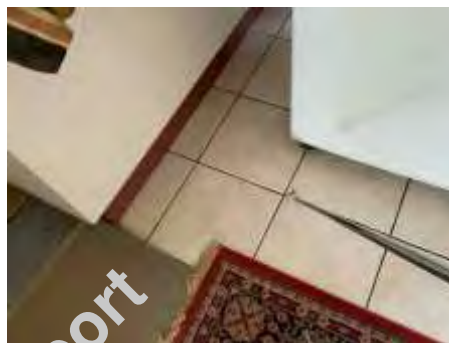
A few drummy tiles to the floor, recommend engaging a tiler to rectify the issue.

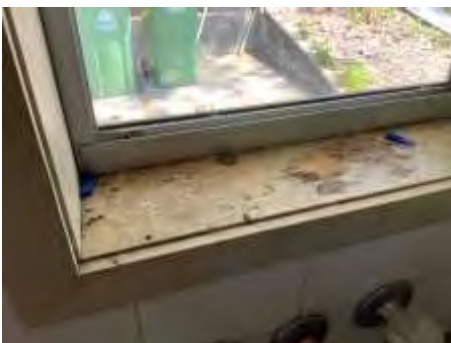
Wood rot to the windows frame. Needs replacement/repair to avoid further deterioration.

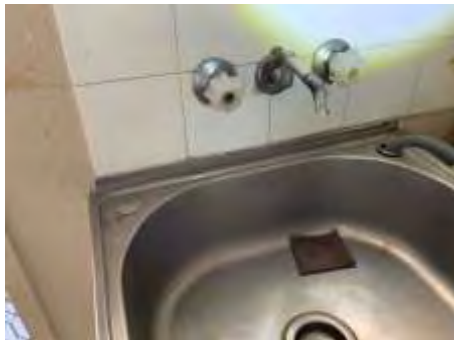
Joins to Laundry tub splash back needs resealing to reduce the risk of water leaks and penetration,

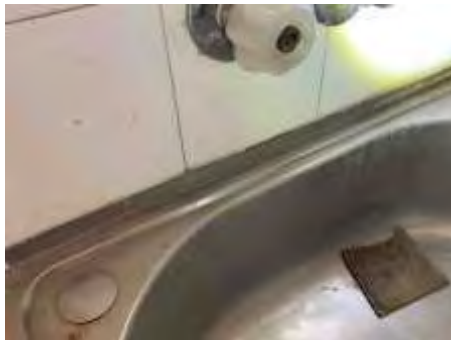
Joins to Laundry tub splash back needs resealing to reduce the risk of water leaks and penetration,

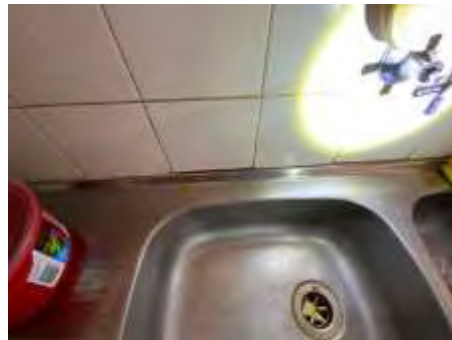
Joins to kitchen bench splash back needs resealing to reduce the risk of water leaks and penetration

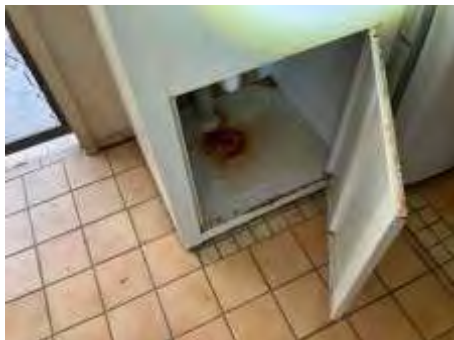
Rust to the laundry cabinet. Replacement needed.

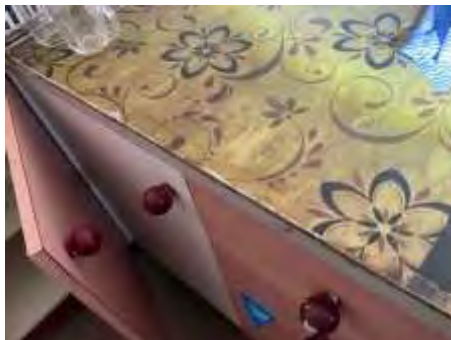
Delamination to the cabinet. Engaging a cabinet maker to replace the affected parts.

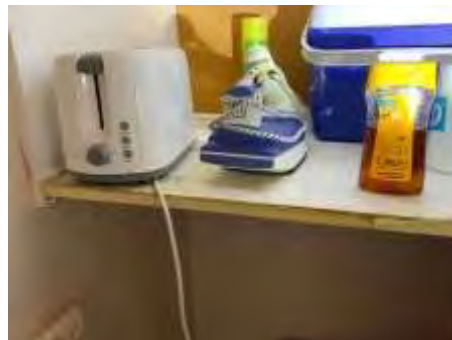
Delamination to the cabinet. Engaging a cabinet maker to replace the affected parts.

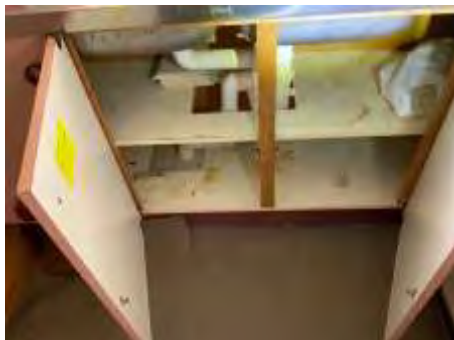
Delamination to the cabinet. Engaging a cabinet maker to replace the affected parts.

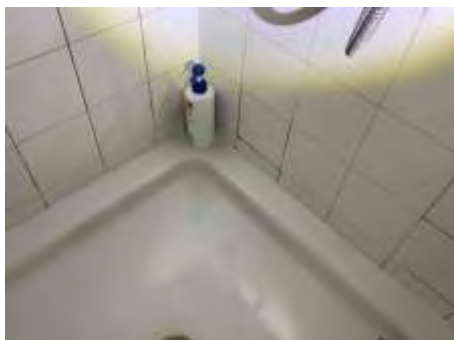
Cracked/loose/missing sealant/grout to parts of bathroom. Recommend resealing to reduce the risk of water leaks and damage

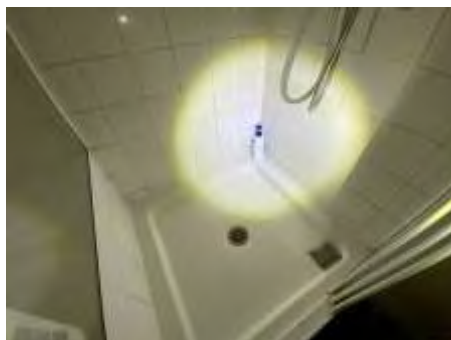
Cracked/loose/missing sealant/grout to parts of bathroom. Recommend resealing to reduce the risk of water leaks and damage

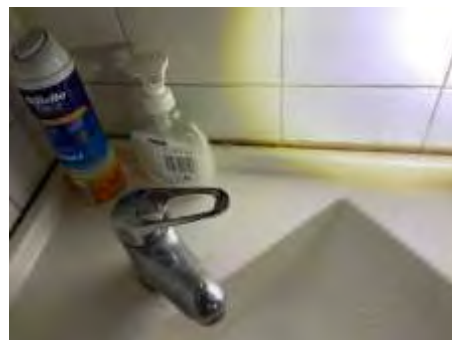
Cracked/loose/missing sealant/grout to parts of bathroom. Recommend resealing to reduce the risk of water leaks and damage

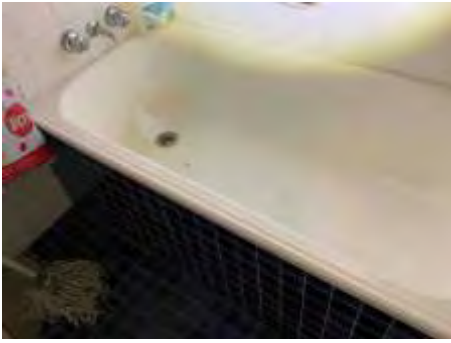
Cracked/loose/missing sealant/grout to parts of bathroom. Recommend resealing to reduce the risk of water leaks and damage

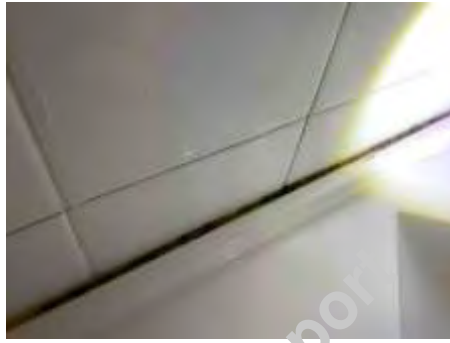
Cracked/loose/missing sealant/grout to parts of bathroom. Recommend resealing to reduce the risk of water leaks and damage

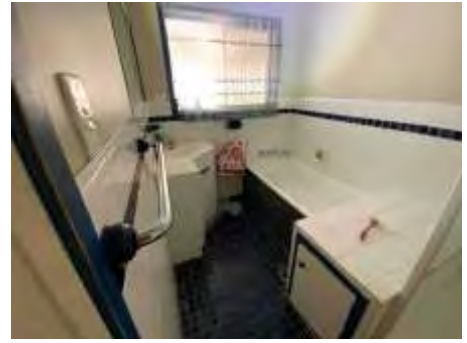
Cracked/loose/missing sealant/grout to parts of bathroom. Recommend resealing to reduce the risk of water leaks and damage

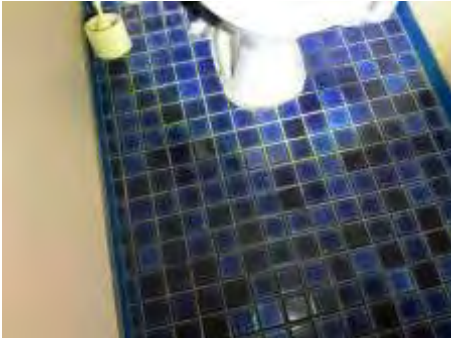
Cracked/loose/missing sealant/grout to parts of bathroom. Recommend resealing to reduce the risk of water leaks and damage

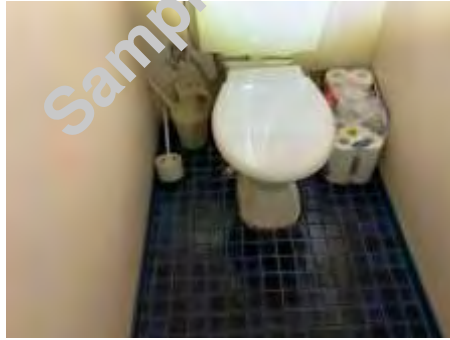
Cracked/loose/missing sealant/grout to parts of bathroom. Recommend resealing to reduce the risk of water leaks and damage

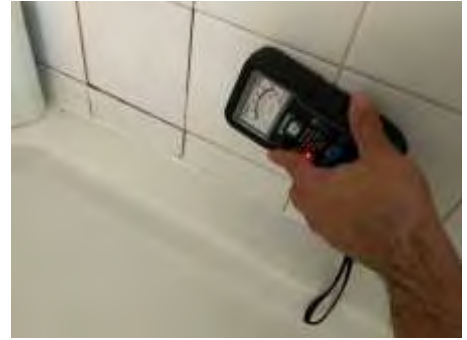
High moisture readings to the walls around the shower. Recommend engaging a builder/plumber for further inspection to determine if the shower needs re-building/waterproofing or it can be repaired easily

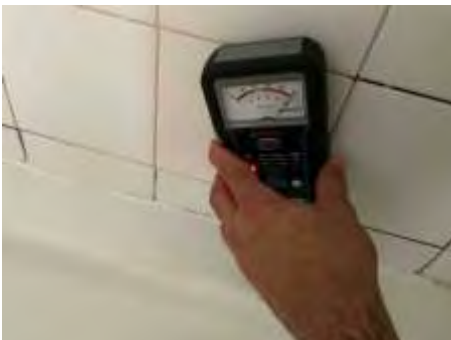
High moisture readings to the walls around the shower. Recommend engaging a builder/plumber for further inspection to determine if the shower needs re-building/waterproofing or it can be repaired easily

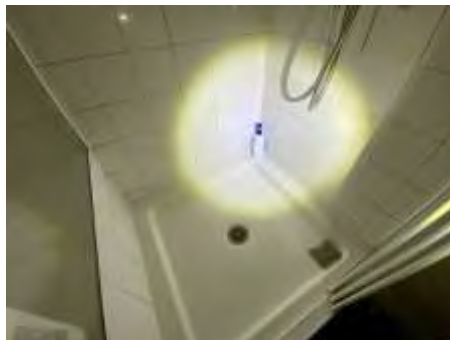
High moisture readings to the walls around the shower. Recommend engaging a builder/plumber for further inspection to determine if the shower needs re-building/waterproofing or it can be repaired easily

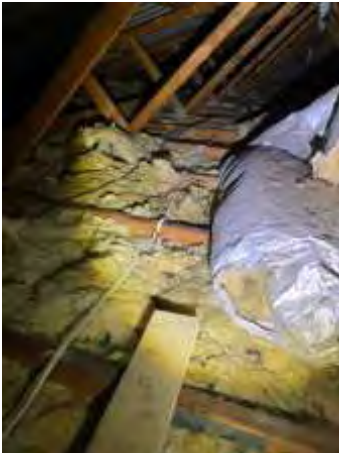
Metal backed insulation installed to the roof space, recommend engaging an electrician and builder to replace the insulation to reduce the risk of electrocution

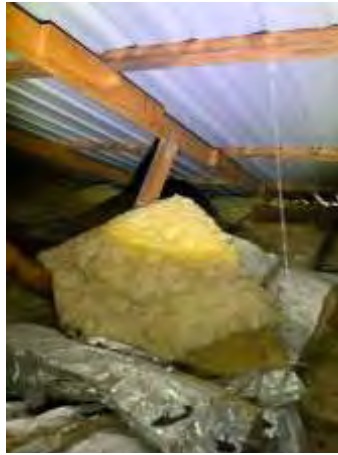
Metal backed insulation installed to the roof space, recommend engaging an electrician and builder to replace the insulation to reduce the risk of electrocution

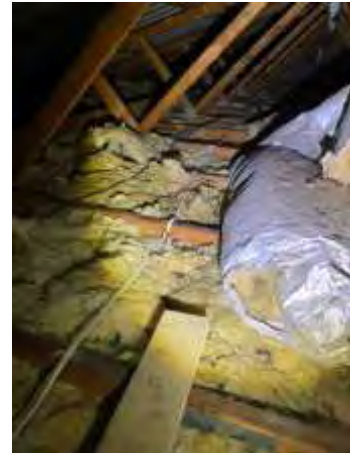
Missing to parts of insulation. Insulation not works as expected. Engaging an insulation technician to refit the missed insulation.

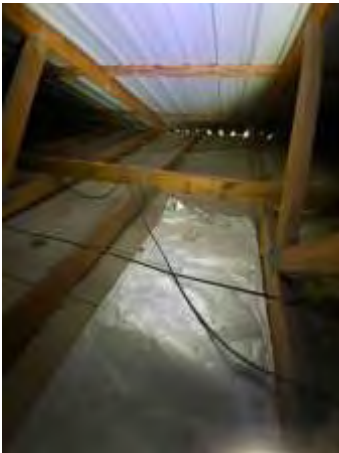
Missing to parts of insulation. Insulation not works as expected. Engaging an insulation technician to refit the missed insulation.

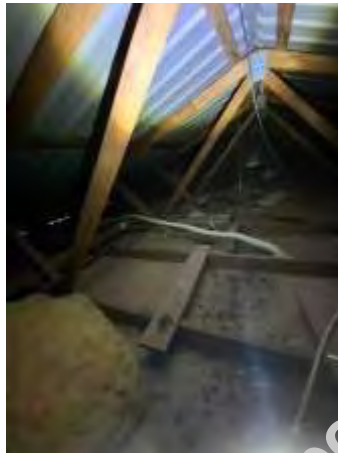
Missing to parts of insulation. Insulation not works as expected. Engaging an insulation technician to refit the missed insulation.

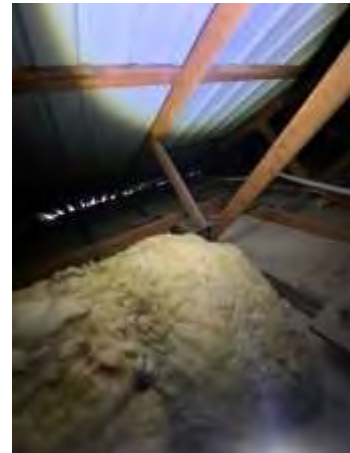
Missing to parts of insulation. Insulation not works as expected. Engaging an insulation technician to refit the missed insulation.

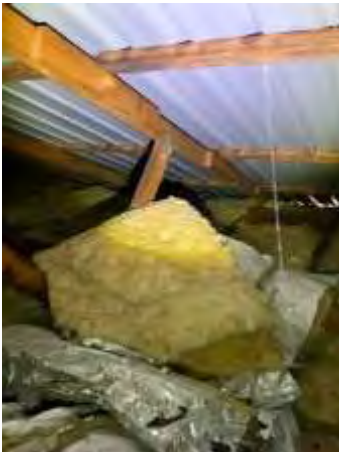
Missing to parts of insulation. Insulation not works as expected. Engaging an insulation technician to refit the missed insulation.

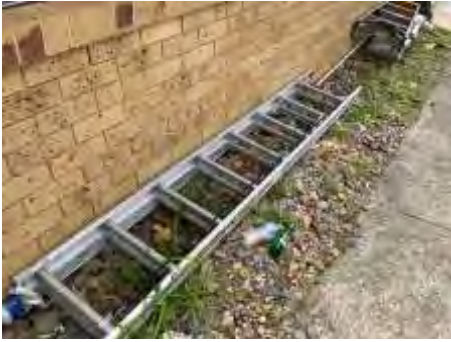
Obstructed weep holes. Recommend exposing 75 mm under the weep holes to reduce the risk of termite attack and water ingress into the building

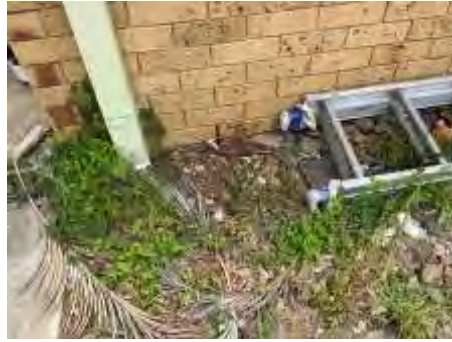
Obstructed weep holes. Recommend exposing 75 mm under the weep holes to reduce the risk of termite attack and water ingress into the building

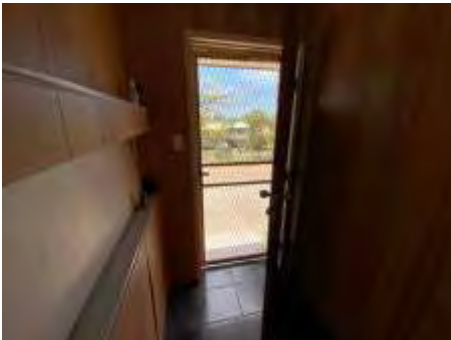
Door is aged/deteriorated. Recommend engaging a carpenter to repair/replace to avoid further deterioration

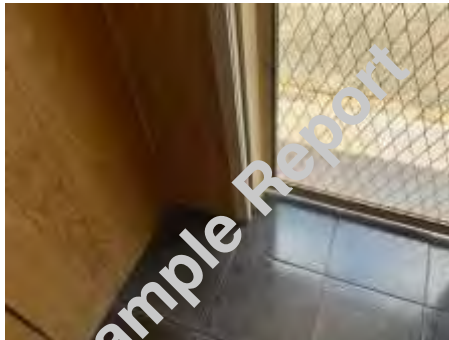
Door is aged/deteriorated. Recommend engaging a carpenter to repair/replace to avoid further deterioration

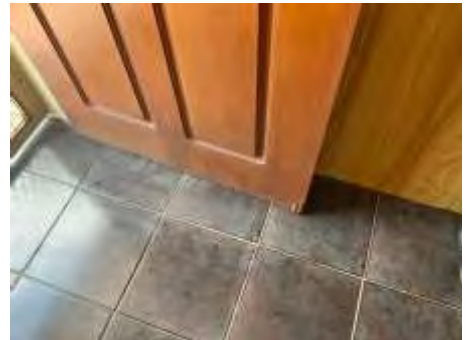
Door is aged/deteriorated. Recommend engaging a carpenter to repair/replace to avoid further deterioration

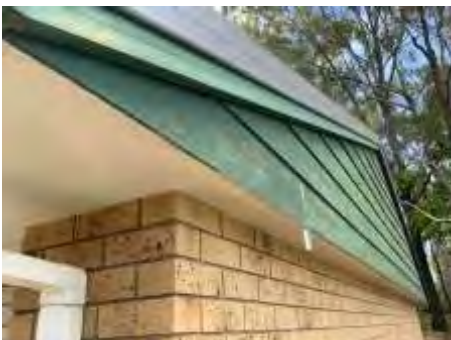
Make sure all the exposed timbers are painted to maximise the life of the timbers

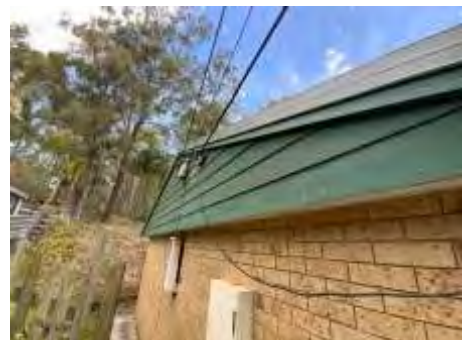
Make sure all the exposed timbers are painted to maximise the life of the timbers

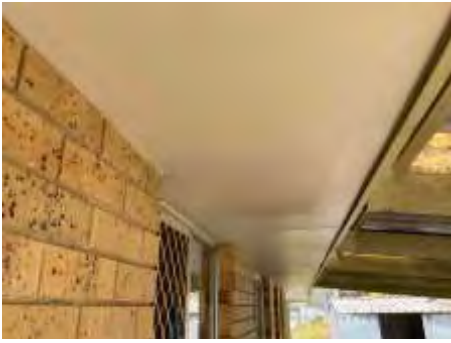
Mould staining visible to parts of the soffit sheets. Recommend engaging a builder to replace the affected sheets.

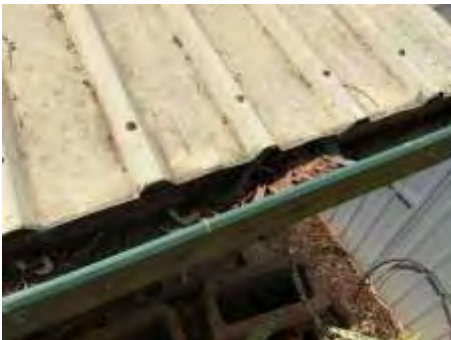
Debris to parts of the gutters. Recommend cleaning to reduce the risk of rust and the gutters overflowing into the building

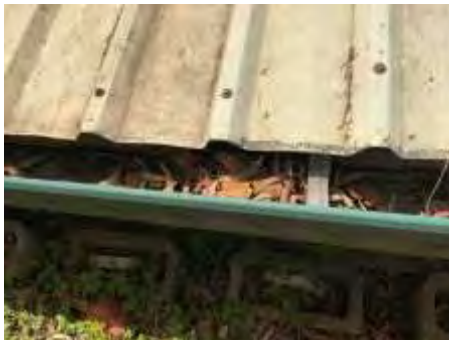
Debris to parts of the gutters. Recommend cleaning to reduce the risk of rust and the gutters overflowing into the building

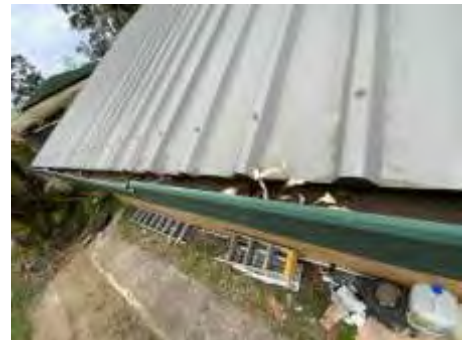
Debris to parts of the gutters. Recommend cleaning to reduce the risk of rust and the gutters overflowing into the building

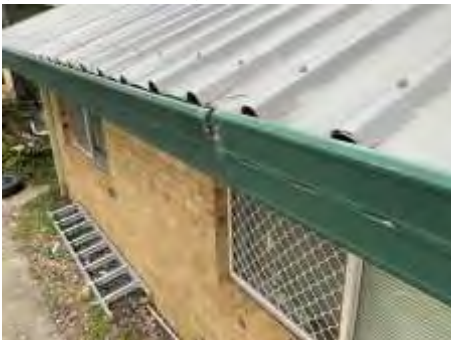
Deformation to the gutter engaging a plumber to repair to avoid water splash to near the slab.

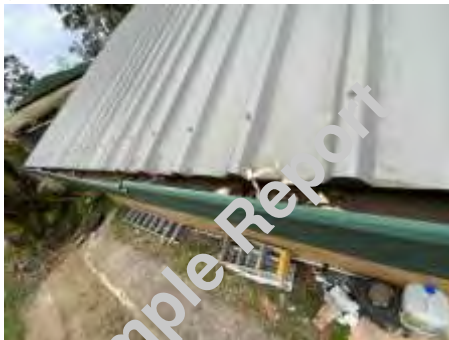
Deformation to the gutter engaging a plumber to repair to avoid water splash to near the slab.

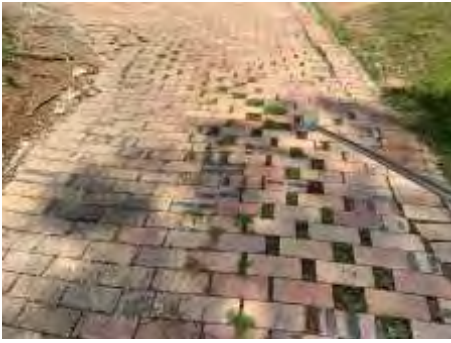
Uneven pathway/driveway, rectify to reduce the risk of people tripping over and personal injury

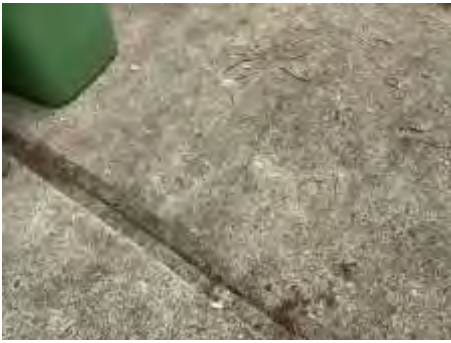
Settlement cracks to parts of the pathway/driveway. Recommend engaging a concreting contractor to repair/replace and avoid further deterioration

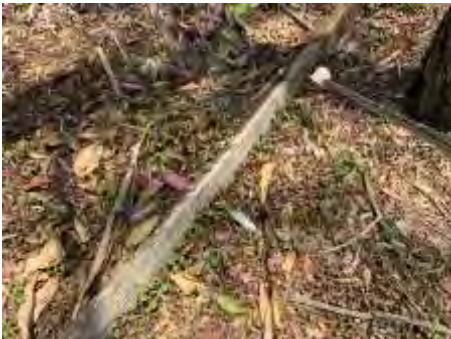
Wood rot to parts of the retaining walls. Recommend engaging a builder to repair/replace and avoid further deterioration

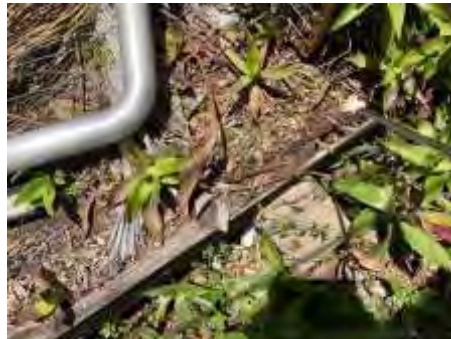
Wood rot to parts of the retaining walls. Recommend engaging a builder to repair/replace and avoid further deterioration

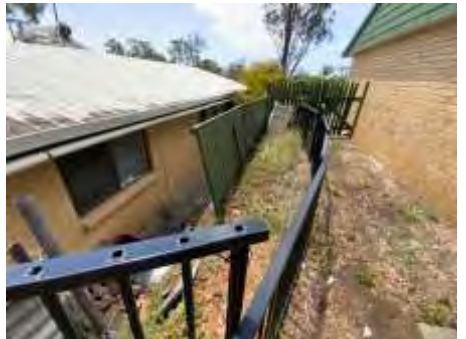
Leaning fences to parts. Recommend engaging a builder/fencer to repair/replace and avoid further deterioration

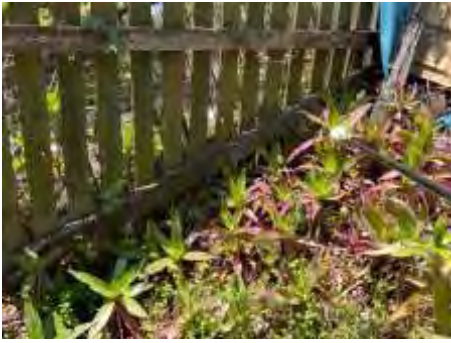
Wood rot to parts of the fences. Recommend engaging a fencing contractor to repair/replace the damaged parts and avoid further deterioration. Make sure all the exposed timbers are painted to maximise the life of the timbers

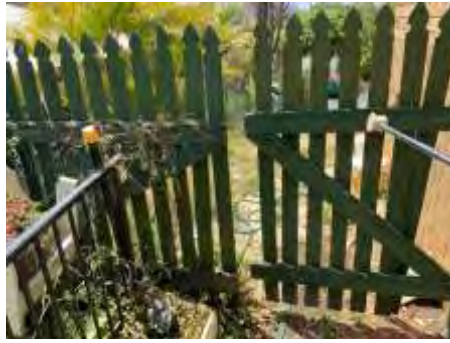
Wood rot to parts of the fences. Recommend engaging a fencing contractor to repair/replace the damaged parts and avoid further deterioration. Make sure all the exposed timbers are painted to maximise the life of the timbers

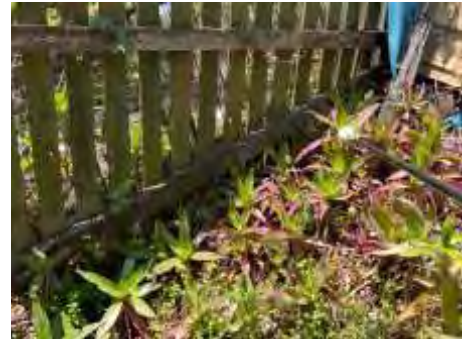
Parts of the fences are in ground contact. Recommend exposing 75mm under the timbers to reduce the risk of wood rot and termite attacks

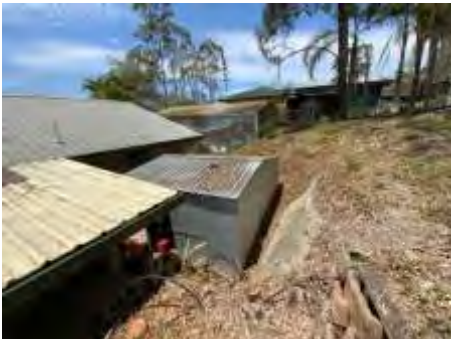
Deterioration to the shed. Needs replacement/repairing

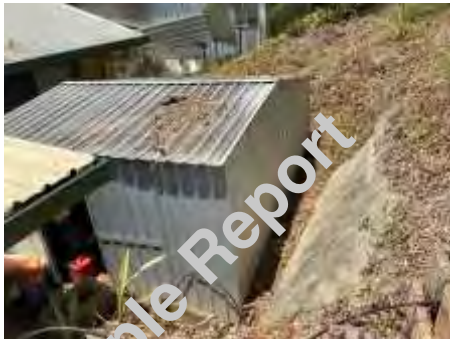
Deterioration to the shed. Needs replacement/repairing

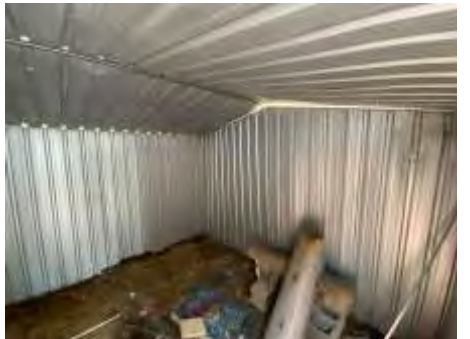
Deterioration to the shed. Needs replacement/repairing

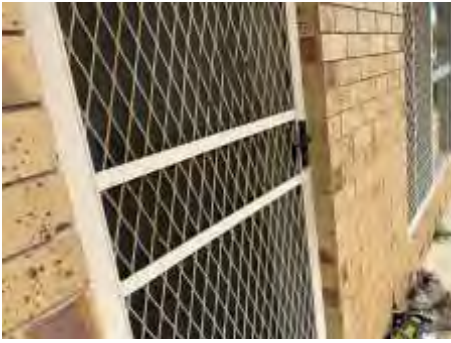
Showing example of minor rusting

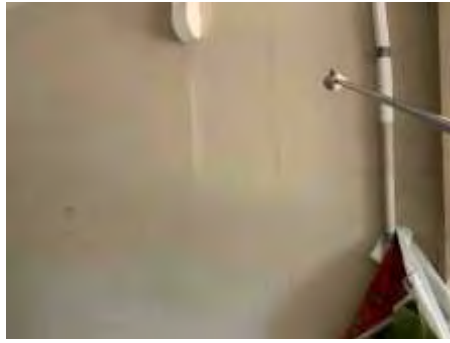
Showing example of scuff marks and paint blemishes

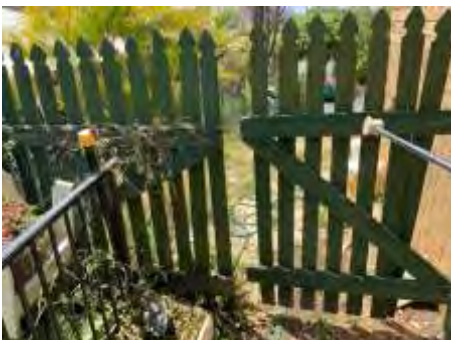
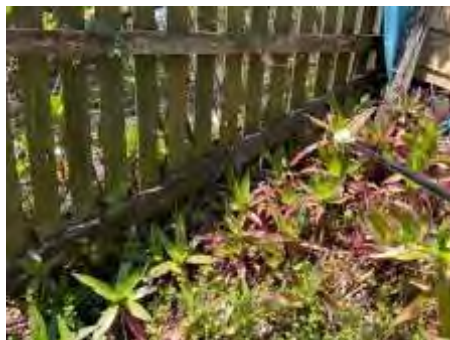
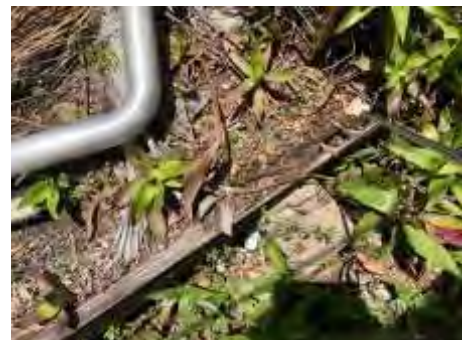
Showing example of fungal decay to timber Showing example of fungal decay to timber Showing example of fungal decay to timber

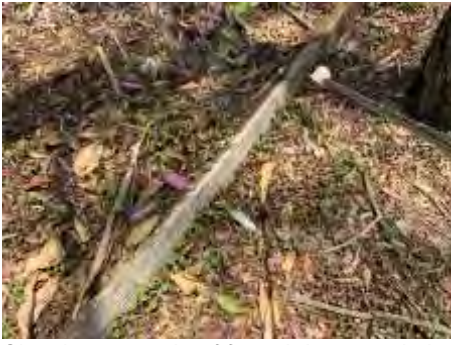
Showing example of fungal decay to timber

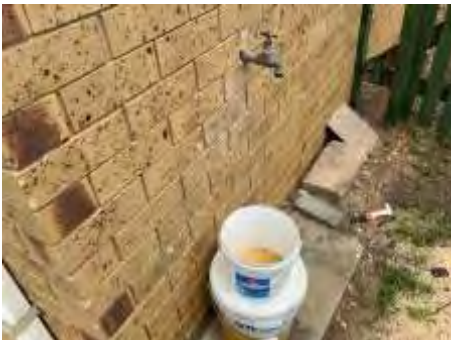
Showing possible source of excessive moisture

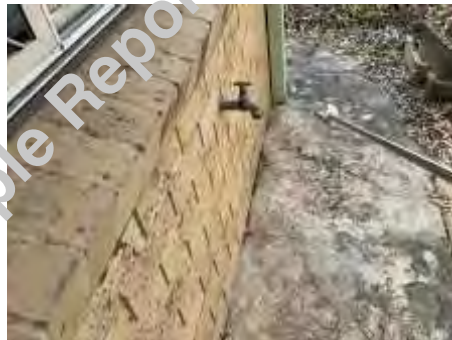
Showing possible source of excessive moisture

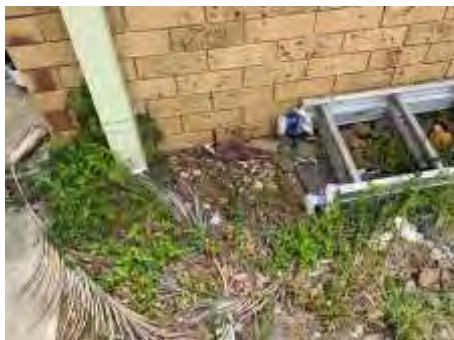
Showing example of bridging/breaching

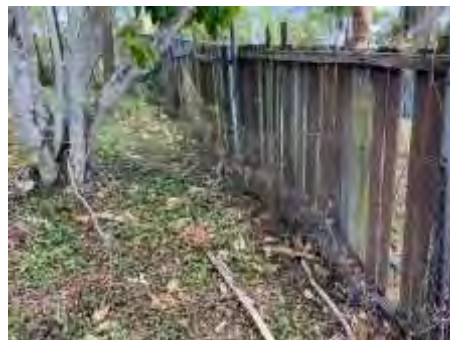
Showing example of bridging/breaching

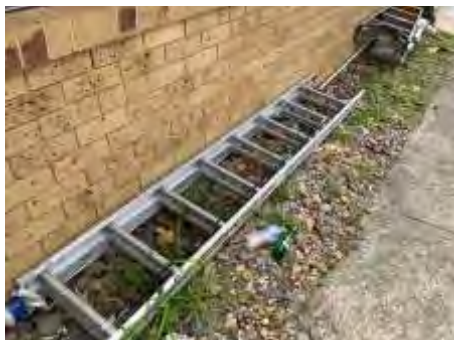
Showing example of conducive conditions

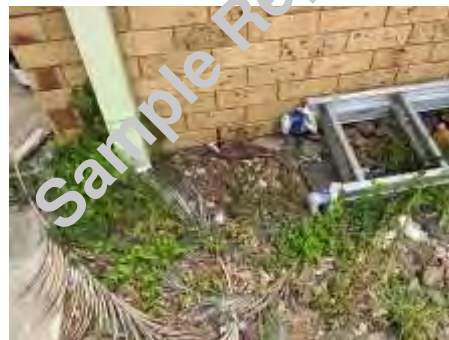
Showing example of conducive conditions

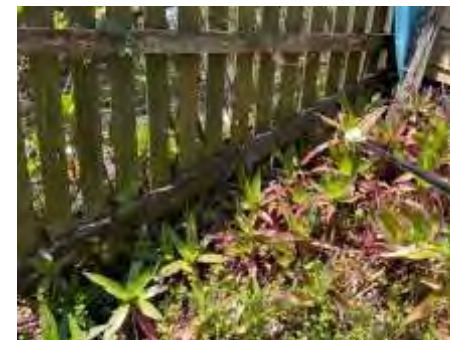
Showing example of conducive conditions

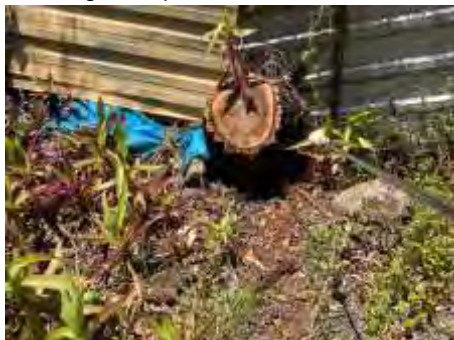
Showing example of conducive conditions

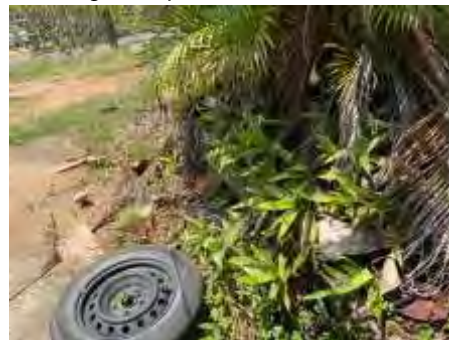
Showing example of conducive conditions
