## Pre-Purchase Standard Property & Timber Pest Report

## PRE-PURCHASE STANDARD PROPERTY & TIMBER PEST REPORT

Report number:	AI23-0
Inspection Date:	24th Mar, 2023
Property Address	Queensland, 4509 Australia

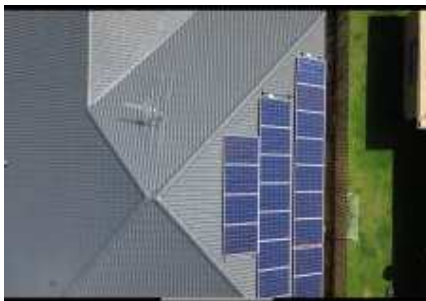
Showing the solar panel on top of the roof

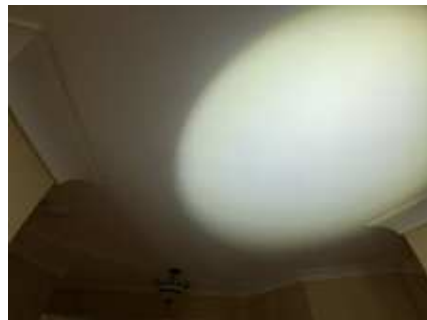
Movement cracks to ceiling and/or cornices. Recommend engaging a plasterer to repairs/replace to prevent further deterioration, Living room

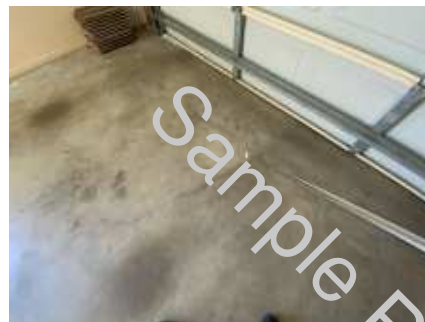
Cracking was observed on parts of the floors. Recommend a structural engineer be engaged to inspect and provide appropriate advice and recommendations to reduce the risk of further deterioration to the building., Garage floor

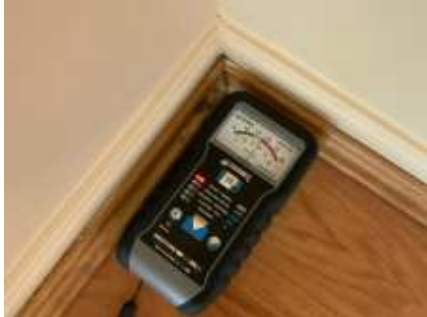
High moisture readings to the walls around the shower. Recommend engaging a builder/plumber for further inspection to determine if the shower needs re-building/waterproofing or it can be repaired easily, Behind the main bathroom shower wall, to the floor and door frame

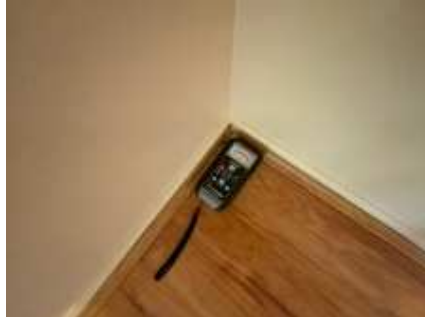
High moisture readings to the walls around the shower. Recommend engaging a builder/plumber for further inspection to determine if the shower needs re-building/waterproofing or it can be repaired easily, Behind the main bathroom shower wall, to the floor and door frame

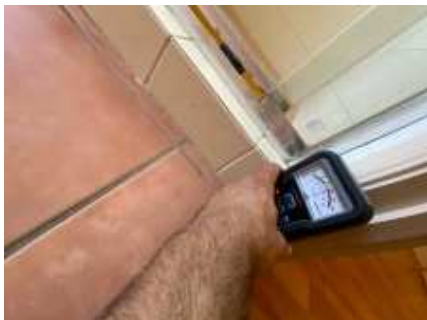
High moisture readings to the walls around the shower. Recommend engaging a builder/plumber for further inspection to determine if the shower needs re-building/waterproofing or it can be repaired easily, Behind the main bathroom shower wall, to the floor and door frame

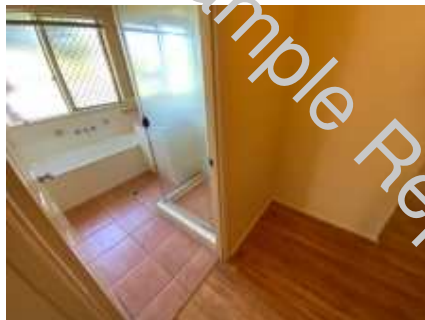
High moisture readings to the walls around the shower. Recommend engaging a builder/plumber for further inspection to determine if the shower needs re-building/waterproofing or it can be repaired easily, Behind the main bathroom shower wall, to the floor and door frame

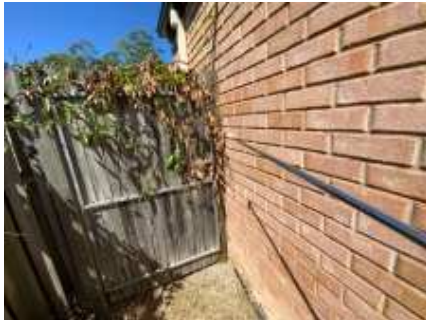
Some parts of the external wall are in contact with the ground. Recommend exposing a minimum of 75mm under the timbers to reduce the risk of termite attack and wood rot, Timber fence attached to the wall and ground

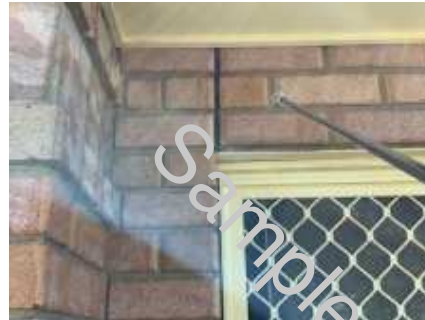
Some parts of the external wall have gaps present. Recommend sealing all the gaps to reduce the risk of water leaks and penetration into the building, Top of the front windows

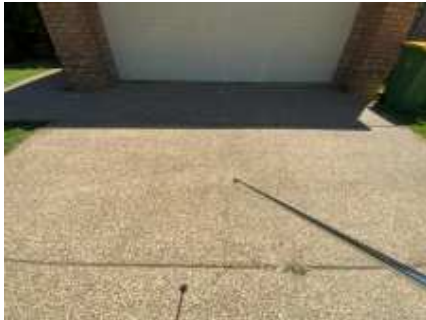
Settlement cracks to parts of the pathway/driveway. Recommend engaging a concreting contractor to repair/replace and avoid further deterioration

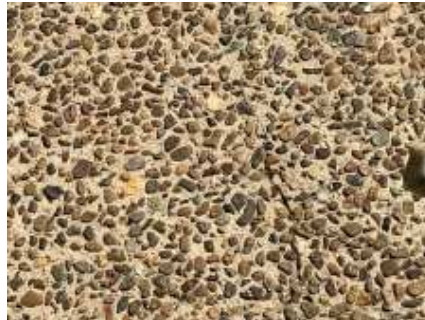
Settlement cracks to parts of the pathway/driveway. Recommend engaging a concreting contractor to repair/replace and avoid further deterioration

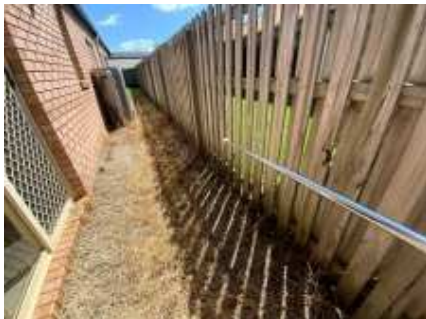
Parts of the fences are in ground contact. Recommend exposing 75mm under the timbers to reduce the risk of wood rot and termite attacks

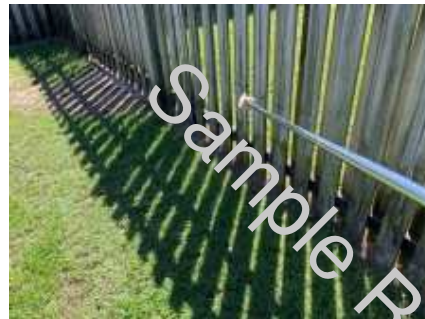
Parts of the fences are in ground contact. Recommend exposing 75mm under the timbers to reduce the risk of wood rot and termite attacks

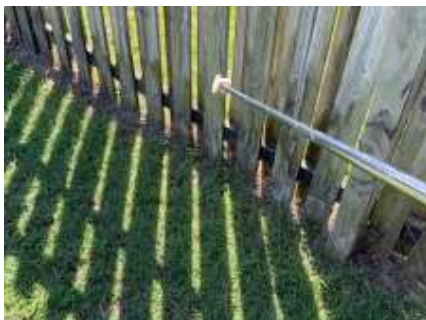
Wood rot to parts of the fences. Recommend engaging a fencing contractor to repair/replace the damaged parts and avoid further deterioration. Make sure all the exposed timbers are painted to maximise the life of the timbers

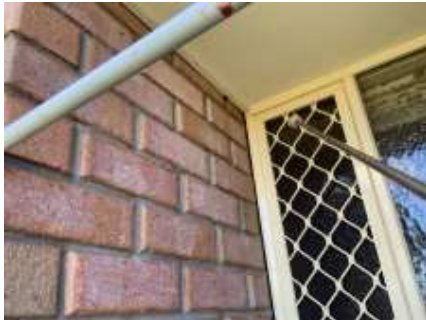
Showing example of settlement cracks, Soffit sheet moulding

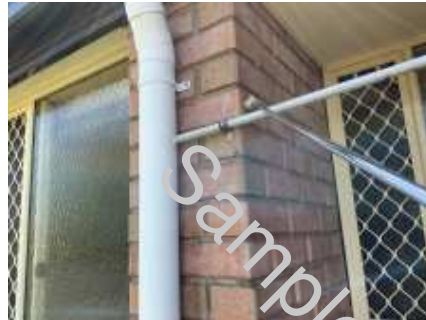
Showing example of minor rusting

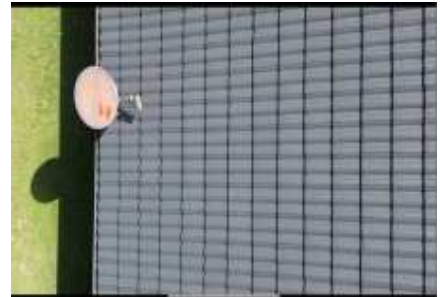
Showing example of minor rusting

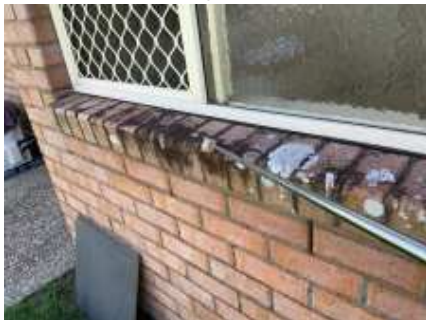
Showing example of the mould/moisture stain to the wall

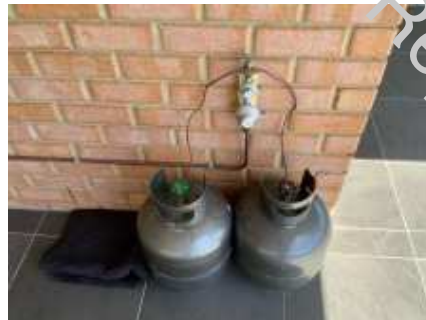
It appears the bottles gas are empty., Any services requiring gas will be inoperable. Recommend further investigations once gas bottles are connected to ensure correctly installed and all services operating correctly. Recommend the above be implemented as soon as practicable

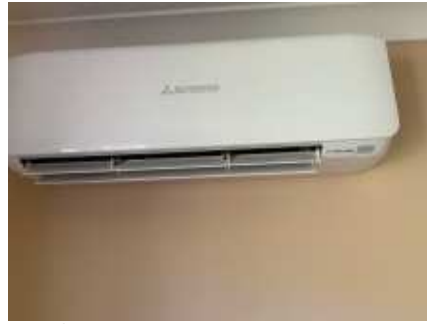
All AC units were working at the time of the inspection, but for a proper testing and gas measurement, a AC technician needs to be engaged

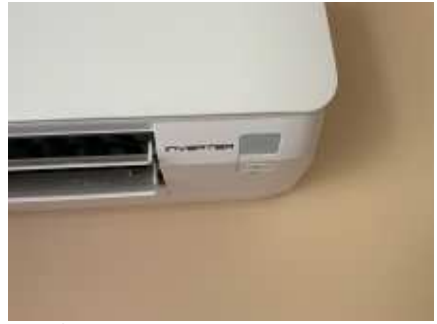
All AC units were working at the time of the inspection, but for a proper testing and gas measurement, a AC technician needs to be engaged

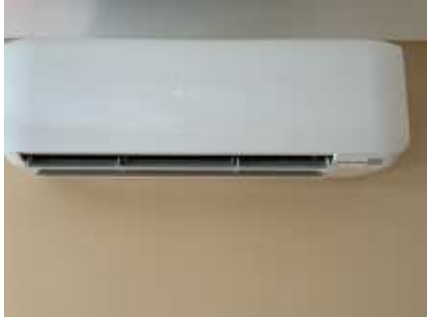
All AC units were working at the time of the inspection, but for a proper testing and gas measurement, a AC technician needs to be engaged

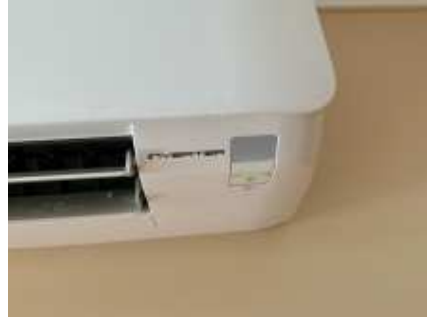
All AC units were working at the time of the inspection, but for a proper testing and gas measurement, a AC technician needs to be engaged

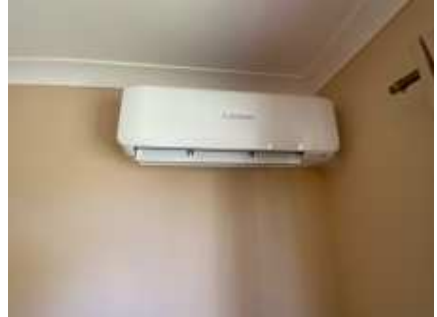
All AC units were working at the time of the inspection, but for a proper testing and gas measurement, a AC technician needs to be engaged

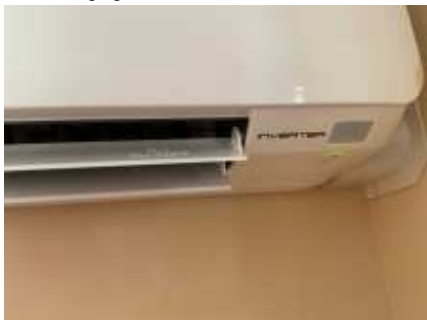
All AC units were working at the time of the inspection, but for a proper testing and gas measurement, a AC technician needs to be engaged

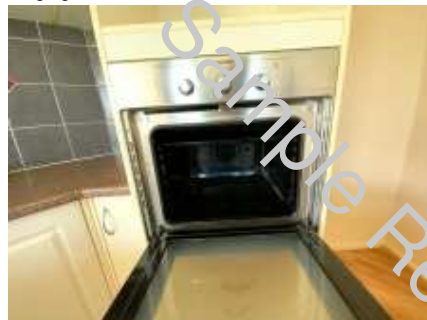
Oven was working at the time of the inspection, but an electrician recommended to test the oven energy efficiency., Some written guides around the knobs are unreadable

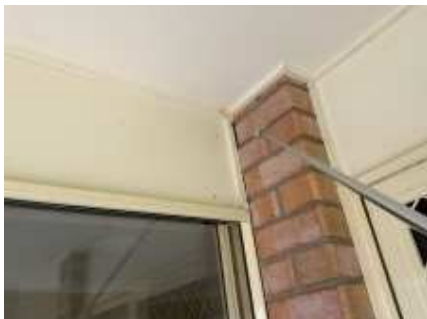
Showing example of the minor gap around door/windows frame, recommend applying silicone to avoid water entry to the wall

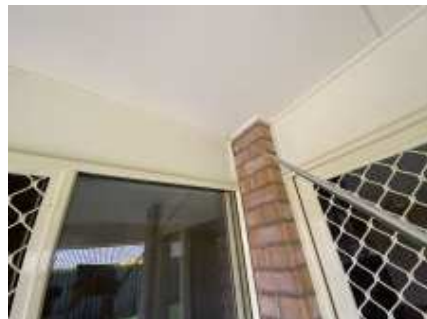
Showing example of the minor gap around door/windows frame, recommend applying silicone to avoid water entry to the wall

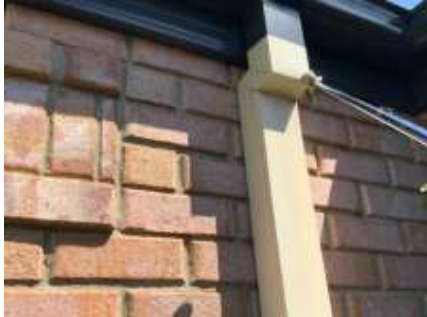
Water stain on front downpipe, it looks like is leaking, a plumber recommended

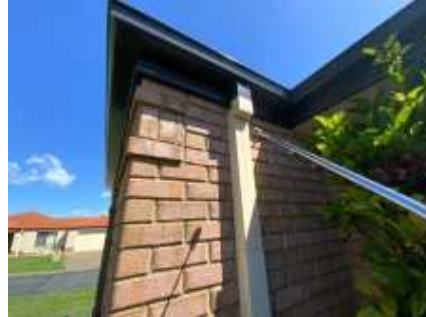
Water stain on front downpipe, it looks like is leaking, a plumber recommended

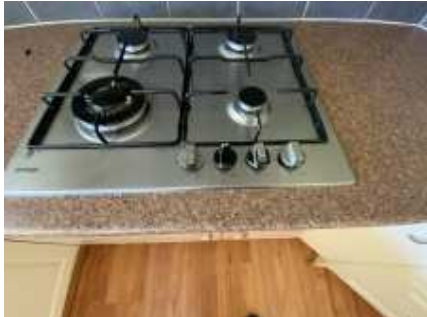
Showing example of the cosmetic defect to the oven/cook top knob.

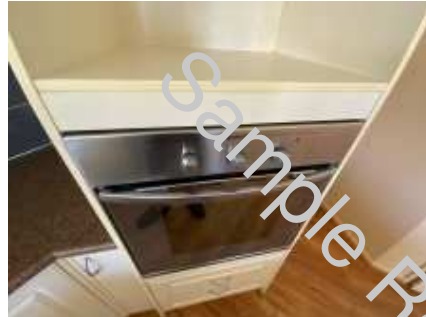
Showing example of the cosmetic defect to the oven/cook top knob.

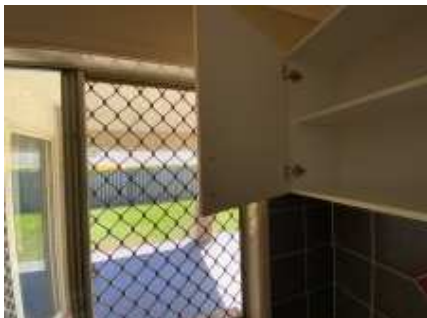
Showing example of loose/missing laminate to the cabinets

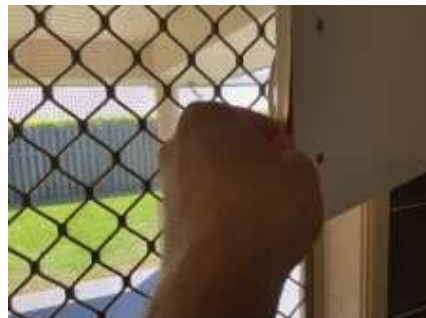
Showing example of loose/missing laminate to the cabinets

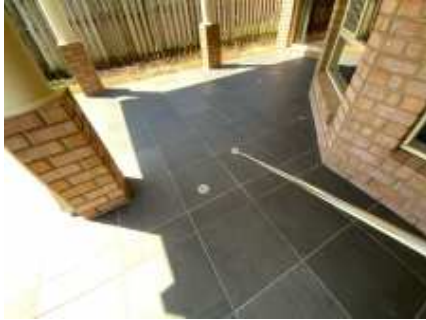
Showing example of the dummy tile

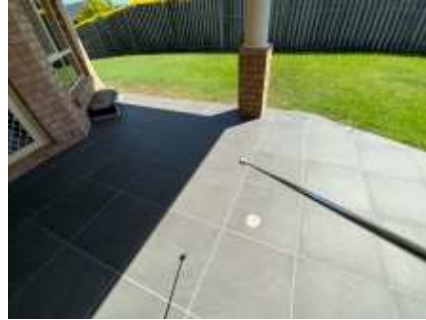
Showing example of the dummy tile

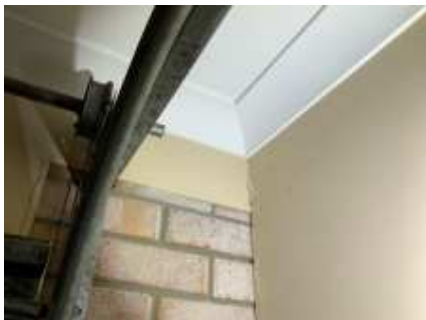
Showing example of settlement cracks, Wall/cornices

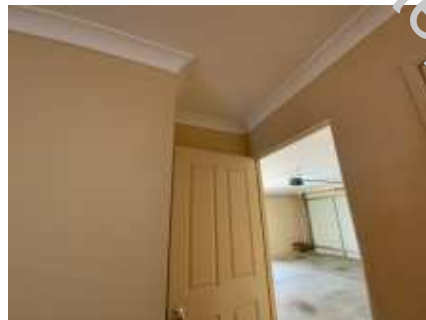
Showing sagging to the ceiling, top of the garage door

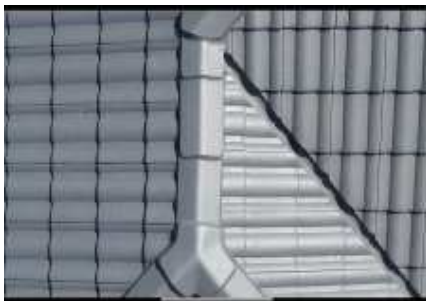
Showing example of settlement cracks, Roof tile, minor scratches.

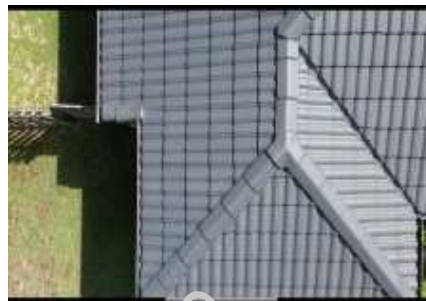
Showing example of settlement cracks, Roof tile, minor scratches.

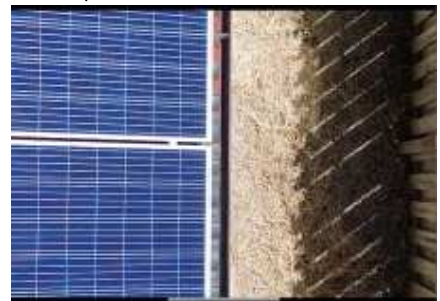
Showing minor scratches to the solar panel

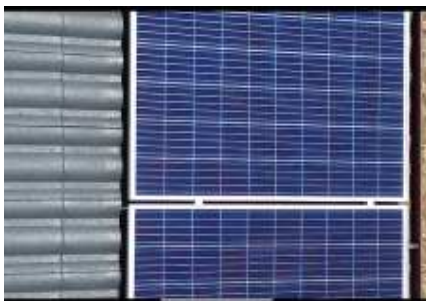
Showing minor scratches to the solar panel

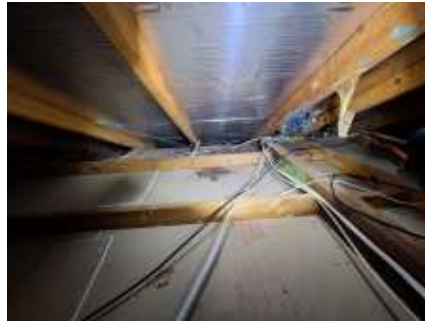
The extent of any visible damage appears:	Undetermined
Location	Termite damage to roofing members
Additional Comments	Recommend replacing all the damaged timbers, Recommend further invasive inspection to the areas with evidence of termite damage to determine if there are any concealed damages to the framing, Recommend exposing a minimum of 75 mm under all the timbers, Recommend an invasive inspection and full eradication of any live termites found to reduce the risk of further termite attacks

Showing sign of the termite working inside the roof space

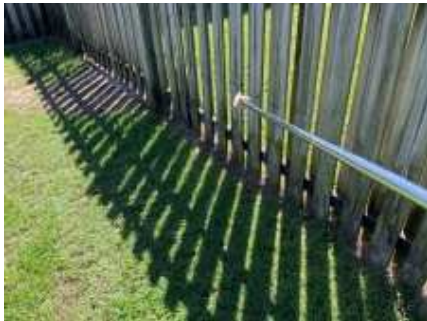
E5 Frequency of future inspections: The next inspection to help detect termite attack is recommended in:	Monthly until the existing termite barrier system verified to be warranted or a new system is installed
E6 Chemical delignification	No evidence was found.
E7 Fungal decay	The following evidence was found:
Location	Wood rot to fences
The extent of any visible damage appears:	Localised
Additional Comments	Recommend replacing all the damaged timbers, Recommend exposing minimum of 75 mm under the timbers to reduce the risk of wood rot and termite attacks

Showing example of the wood rot to the timber

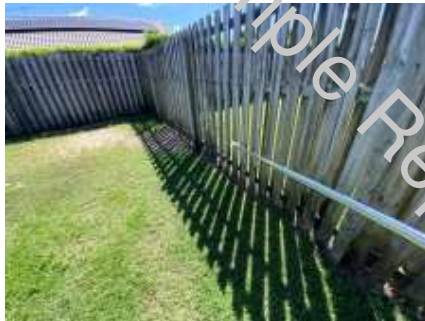
Showing example of the wood rot to the timber

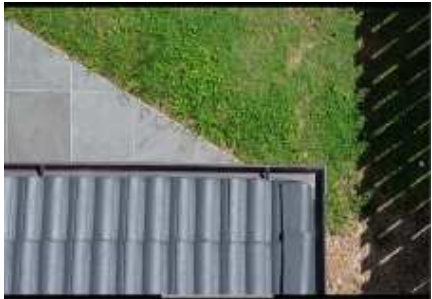
Additional Comments	Excessive moisture to walls around the shower area. Recommend engaging a builder for further inspection to determine if the shower needs re-building/waterproofing or is easily repaired, Recommend re-sealing the joins to the shower screen(s), External taps require a drain underneath them. Recommend engaging a plumber to rectify, Ensure all Rainwater Goods (Gutters, Downpipes, Rain harvesting equipment) have been cleaned regularly, and are debris free. (Min two times a year highly advised). Any blockages or clogged systems might lead to overflowing and creating conducive conditions to damage Main Building Structures (Timber frame structure, Soffit sheets, internal Ceiling panels and etc).
---------------------	---

Showing possible source of excessive moisture

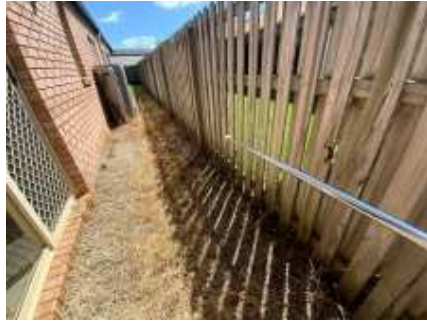
Additional Comments	Timbers in ground contact. Recommend exposing minimum 75 mm under the timbers to allow for visual inspection zone and reduce the risk of termite attacks and wood rot. Due to the applied termite barrier, the degree of risk associated with these bridging elements may be reduced. Recommend maintaining a chemical barrier as a part of a termite management system along with regular visual inspections. It appears several elements of the external fixture may be bridging the termite barrier. This may allow for concealed termite entry into the building. Recommend engaging a pest technician to advise on rectification works required. Recommend engaging a technician to rectify to reduce the risk of termite attack and structural damage
---------------------	---

Showing example of the bridging/breaching

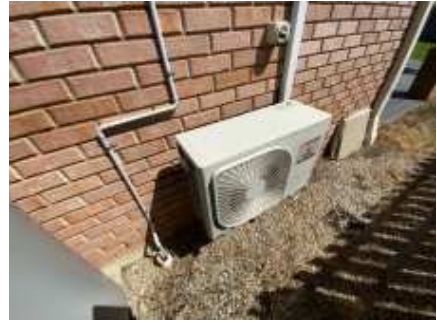
Showing example of the bridging/breaching

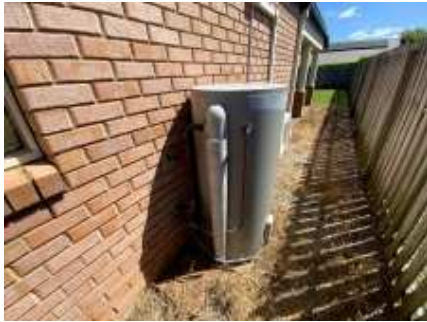
Showing example of the bridging/breaching
